Sample Reported Part Alert

DAC4815AP

Manufacturer: BURR-BROWN CORP
Date Code: 9934
Lot Code: 99347469
Country of Origin: USA
Suspect Counterfeit: Yes
Date Reported: 06/27/2014

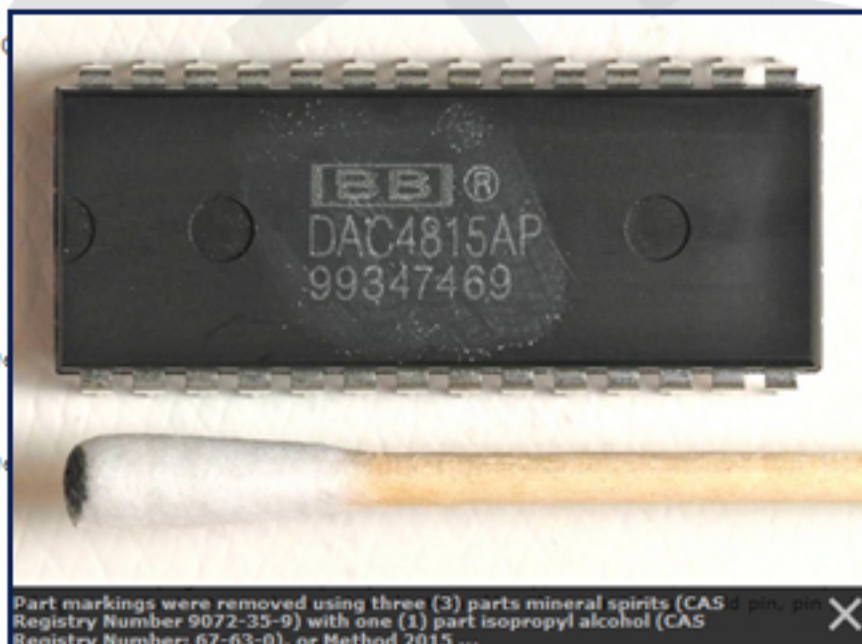
Evidence of refurbishing/retinning present

Evidence of tampering present

Parts Failed Solvent Test for Remarking (Marking Permanency Testing - MPT)

- Secondary coating/blacktopping lifted during test
