THE FAKE CISCO

Hunting for backdoors in
Counterfeit Cisco devices

Dmitry Janushkevich

Version 1.0, July 2020

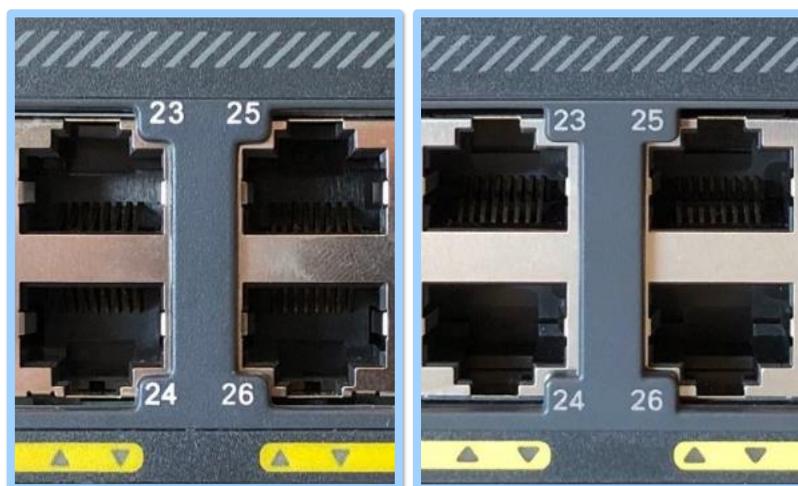
Figure 1. The suspected counterfeit switch (on the left) has port numbers in bright white, while the known genuine device has them in grey. The text itself is misaligned. The triangles indicating different ports are different shapes.

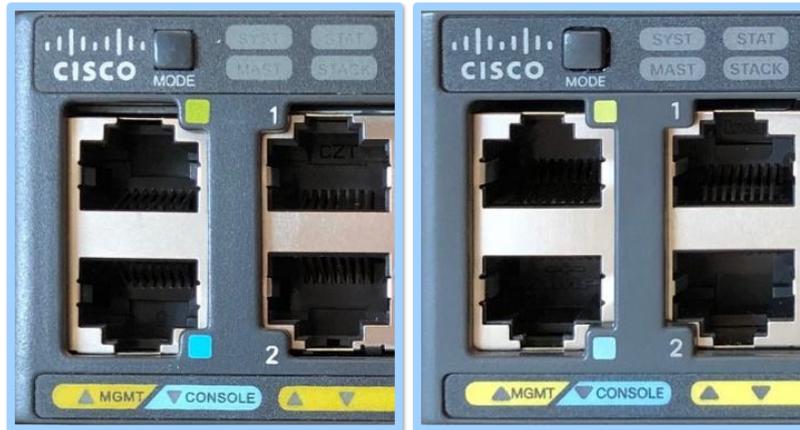
Figure 2. The mode button’s shape is slightly different. The square next to the management port is greenish on the counterfeit switch. On the genuine device, it is bright yellow.

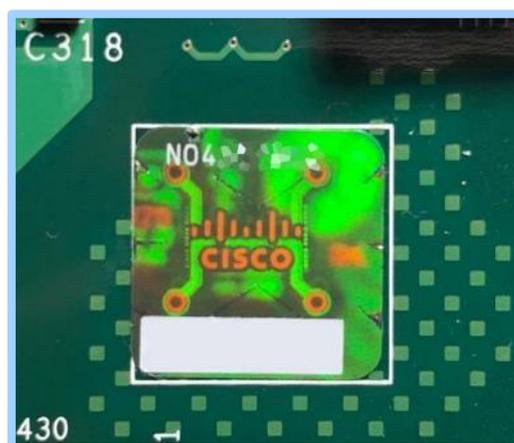
The absence of a holographic sticker on the counterfeit units was immediately noticeable. While its presence on the Genuine unit was not a guarantee of authenticity, its absence typically indicated a counterfeit.

Figure 3. Legitimate holographic sticker which was absent on both counterfeit units.

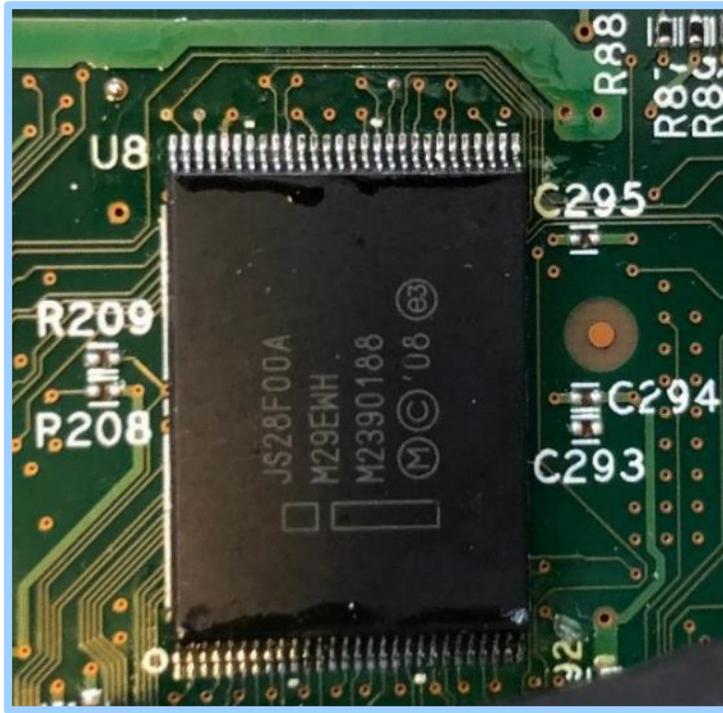
The Flash part numbers were found to be different, albeit both identifying 1Gbit parallel NOR Flash devices. The Genuine unit had Spansion p/n S29GL01GS11TFIV1 installed, while the counterfeit devices were installed with Micron/Intel p/n JS28F00AM29EWH. This could be attributed to the fact that the Genuine unit was identified as V5 while the counterfeits were V1. It is hard to say without comparing devices of the same version whether this was an indicator. It could also be the result of the manufacturer swapping in cheaper parts.

Figure 7. U8, an 1Gbit NOR Flash. PCB rework evidence on the Counterfeit A unit: soldering flux residue on and around the Flash IC is present.

What was more concerning, was the presence of PCB rework traces around the Flash IC on the Counterfeit A unit. While it could be the case the unit was legitimately repaired, no record of such activity was found via available sources. This led us to conclude that, at some point, the Flash chip had been replaced. This may have been part of legitimate repair activities; however, it is not typical for legitimate repair shops to leave flux residues on the board.

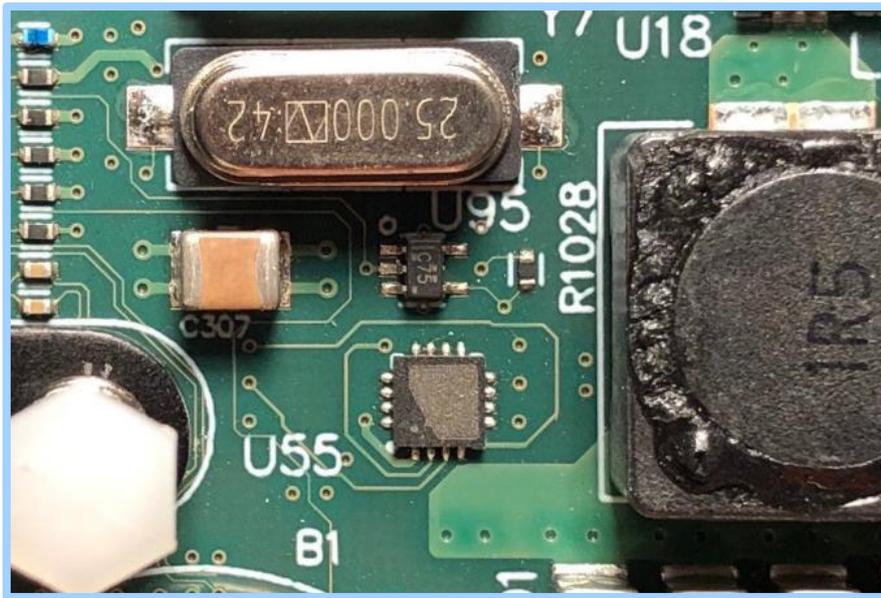
The Counterfeit B unit was found to have one significant difference when compared to other units: the presence of components with their top marking removed with a laser; the components are U55 and U10006.

Whereas the same U55 component is a serial EEPROM in the TSSOP-8 package in other units, the Counterfeit B unit sported a QFN16 package. This could be a legitimate engineering change when producing a new board revision, but it is unusual for an I²C EEPROM to be manufactured in such a package. Furthermore, there is no realistic reason to remove top marking for such a simple part.

Figure 10. U55, an unknown component with top marking removed.

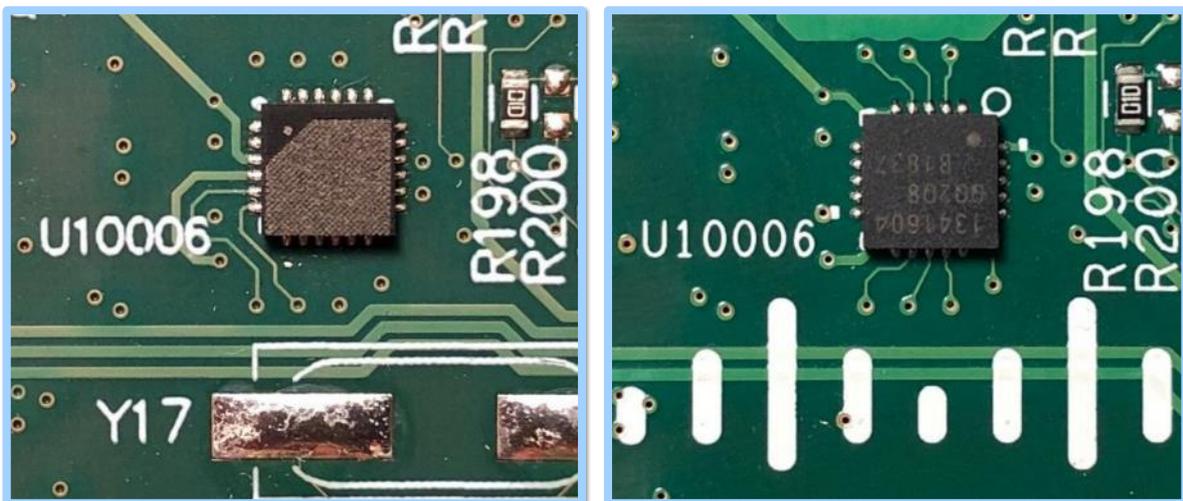
The other component with its top marking removed was U10006, bearing a nondescript top marking even in a genuine unit: 1341604/QQ2Q8/B1837. Unfortunately, this made determining the exact function of this component very challenging.

Figure 11. U10006, another component with top marking removed in Counterfeit B. The Genuine unit to the right for comparison. Note silkscreen quality was lacking on the counterfeit board.

Note the many similarities in via positioning; they matched almost exactly and followed almost the same routing for traces connecting to the passive components on the right. However, U10006 was not only rotated, it also appeared to have a different pinout compared to the genuine board. Pin 1 marking was also very different both on silkscreen and the component itself.

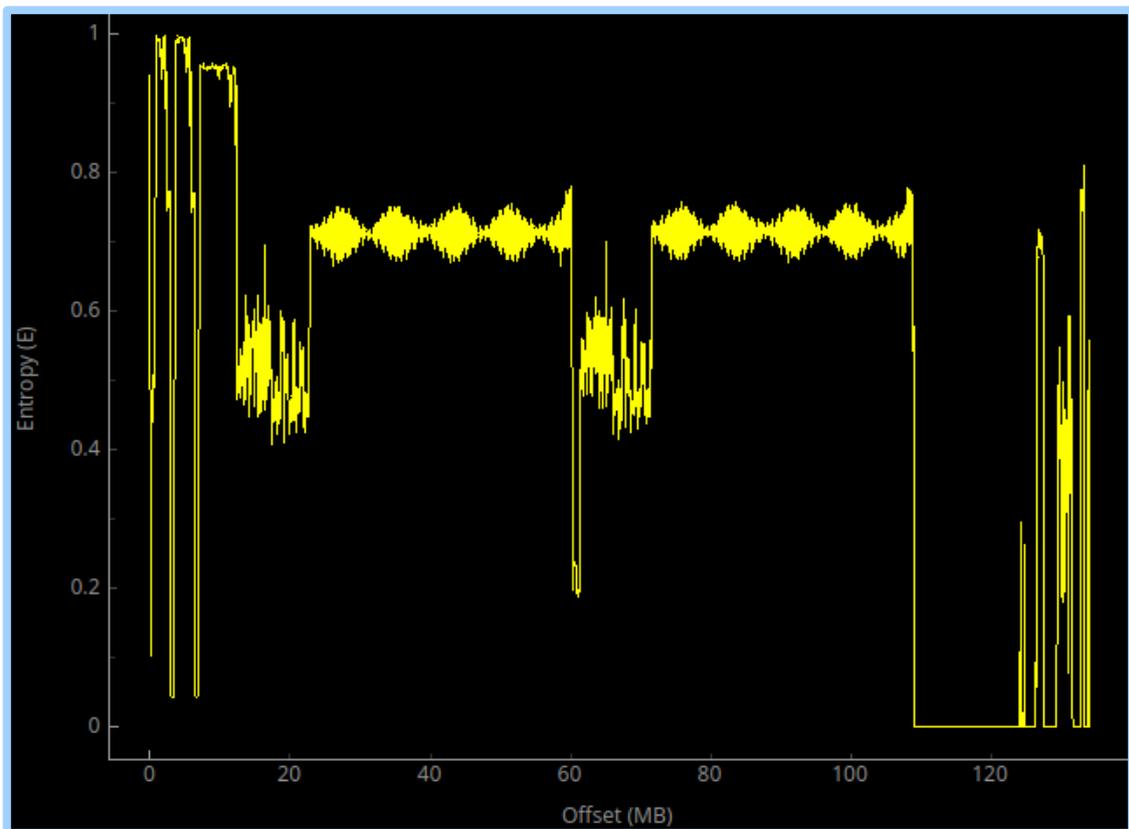
Figure 16. Entropy graph of the suspect Flash image obtained from the Counterfeit A unit.

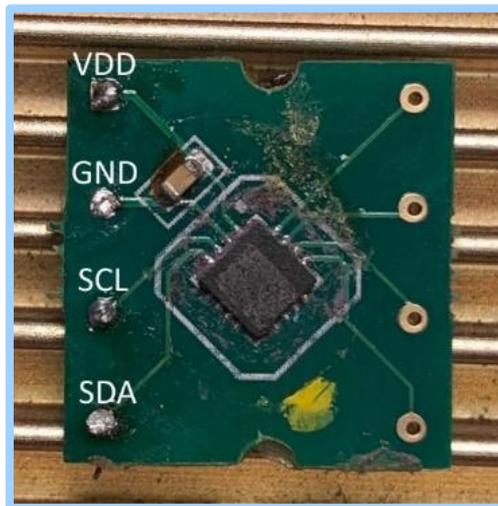
What piqued our interest in the case of Counterfeit A was the "implant" added in conjunction with a serial EEPROM chip. What was the reason for such an unusual and obvious addition? Furthermore, the same chip had been replaced with a completely different package in Counterfeit B.

Figure 19. The implant PCB, disconnected from the unit, with the resin blob removed. As with Counterfeit B, the top marking was erased.

Counterfeit A contained "add-on" circuitry which exploited a race condition in the SLIMpro ROM code to bypass SLIMpro software verification. It did this by intercepting EEPROM control signals, replacing certain bytes in the image being loaded to modify software behavior. It appears the processor PCB in this unit was not modified.
