Part: AM79C972BVI
MFG: ADVANCED MICRO
DEVICES INC
D/C: 1040
L/C:
Origin: Korea
Status: SC
Reported: 11/23/2015

**Remarking & Resurfacing Testing Revealed:
Parts Failed Resistance To Solvents (RTS) -
Acetone**

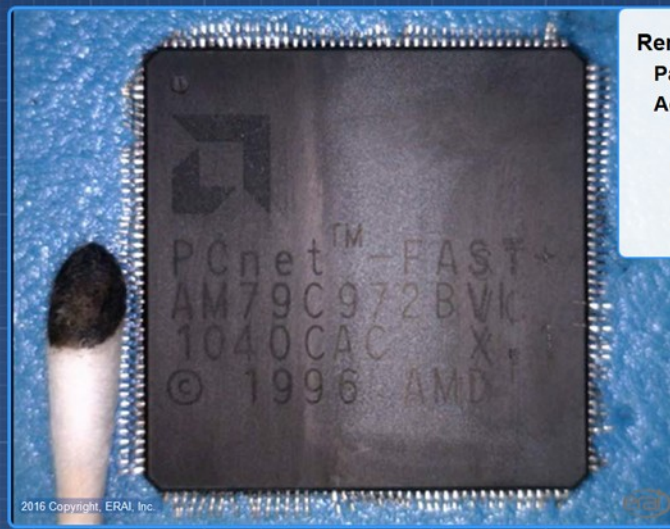
Surface material was removed using acetone
(e.g. CAS Registry Number 67-64-1)
Previous part markings (e.g. ghost markings)
visible after test
