***Non-compliant or Suspect Counterfeit
Packaging Materials Can Lead to
ESD Hazards & Long-Term Storage Issues
and Pose Issues in Handling,
Inspection and Manufacturing
1:45 PM to 4:15 PM***

*Bob Vermillion, CPP/Fellow
Certified, ESD Engineer-iNARTE
RMV Technology Group, LLC
Member G-19 & G-21 Committees
NASA-AMES Research Center
Moffett Field, CA 94035
19 April 2013*

Non-compliant or Suspect Counterfeit Materials Can Lead to ESD Hazards and Long-Term Storage Issues

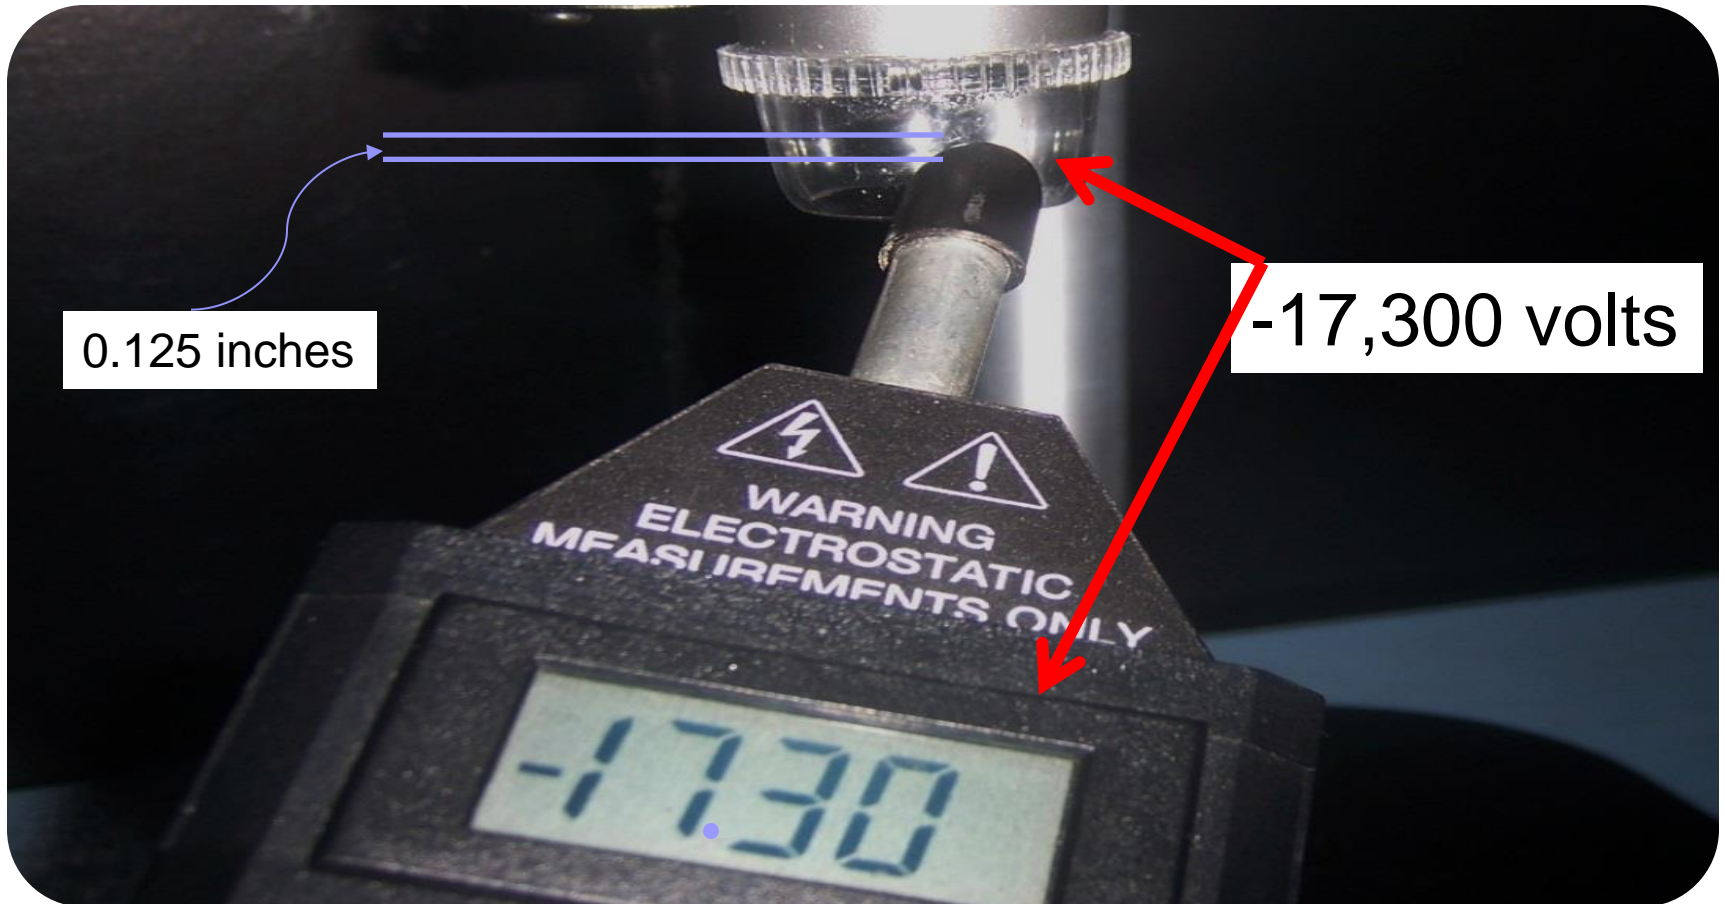
Adjustment Cap at 20%RH

0.125 inches

-17,300 volts

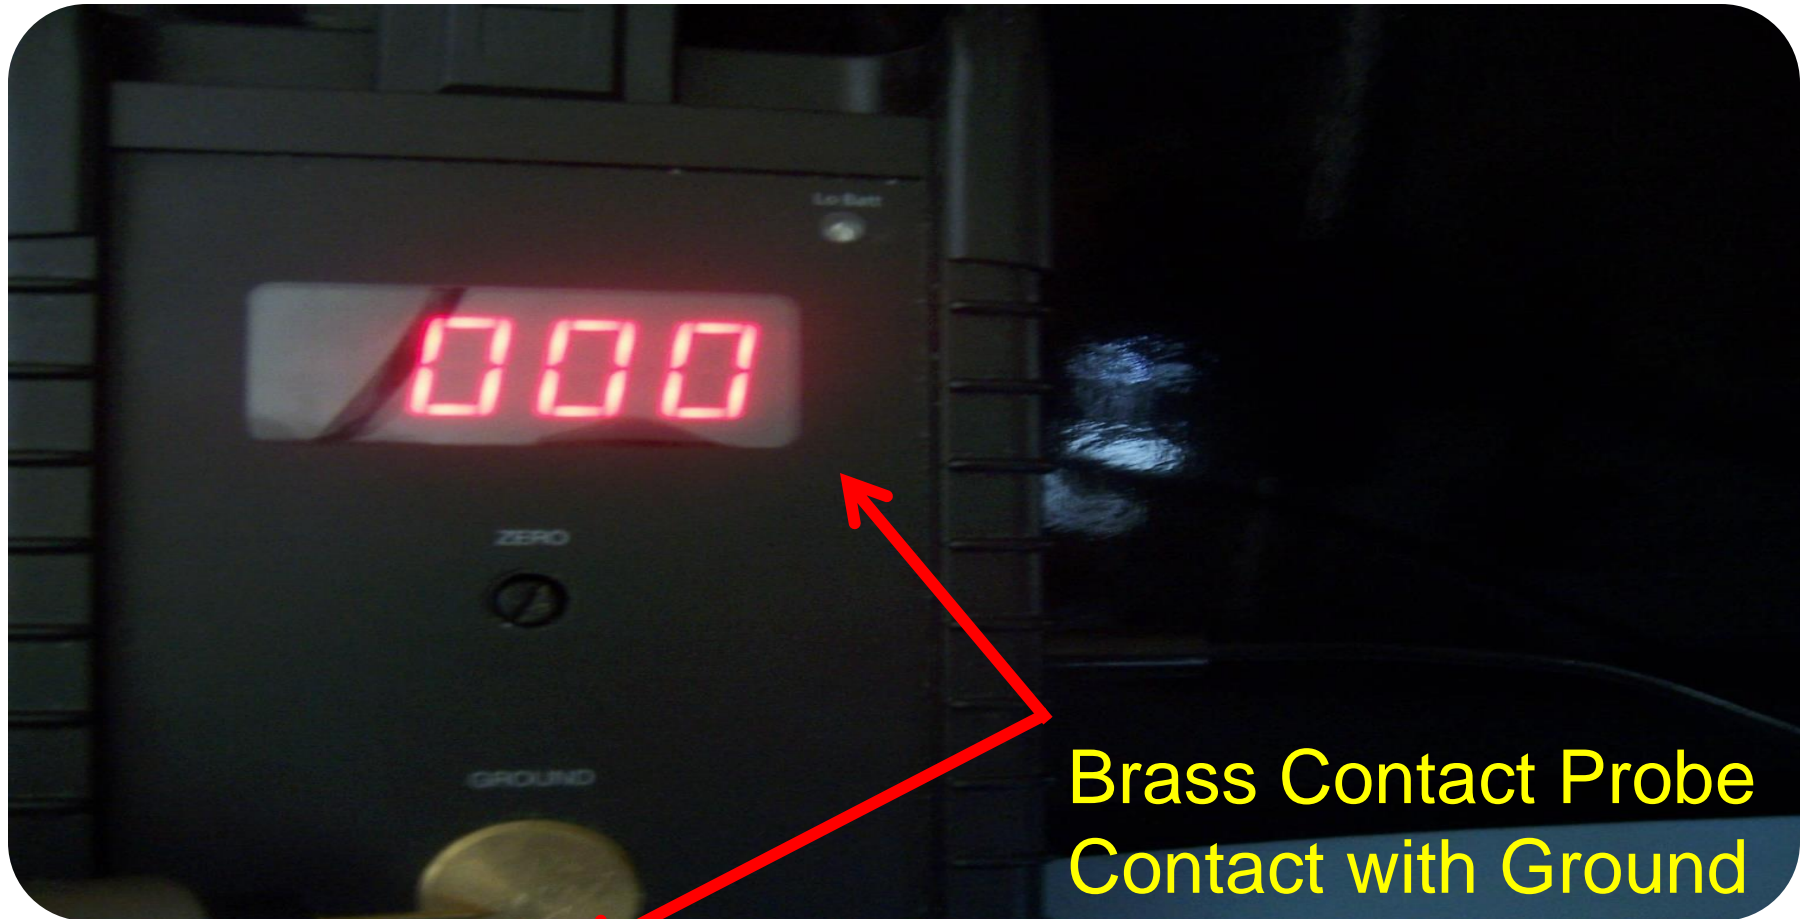
Contact Voltage Charge (Method 1)

Brass Contact Probe
Contact with Ground

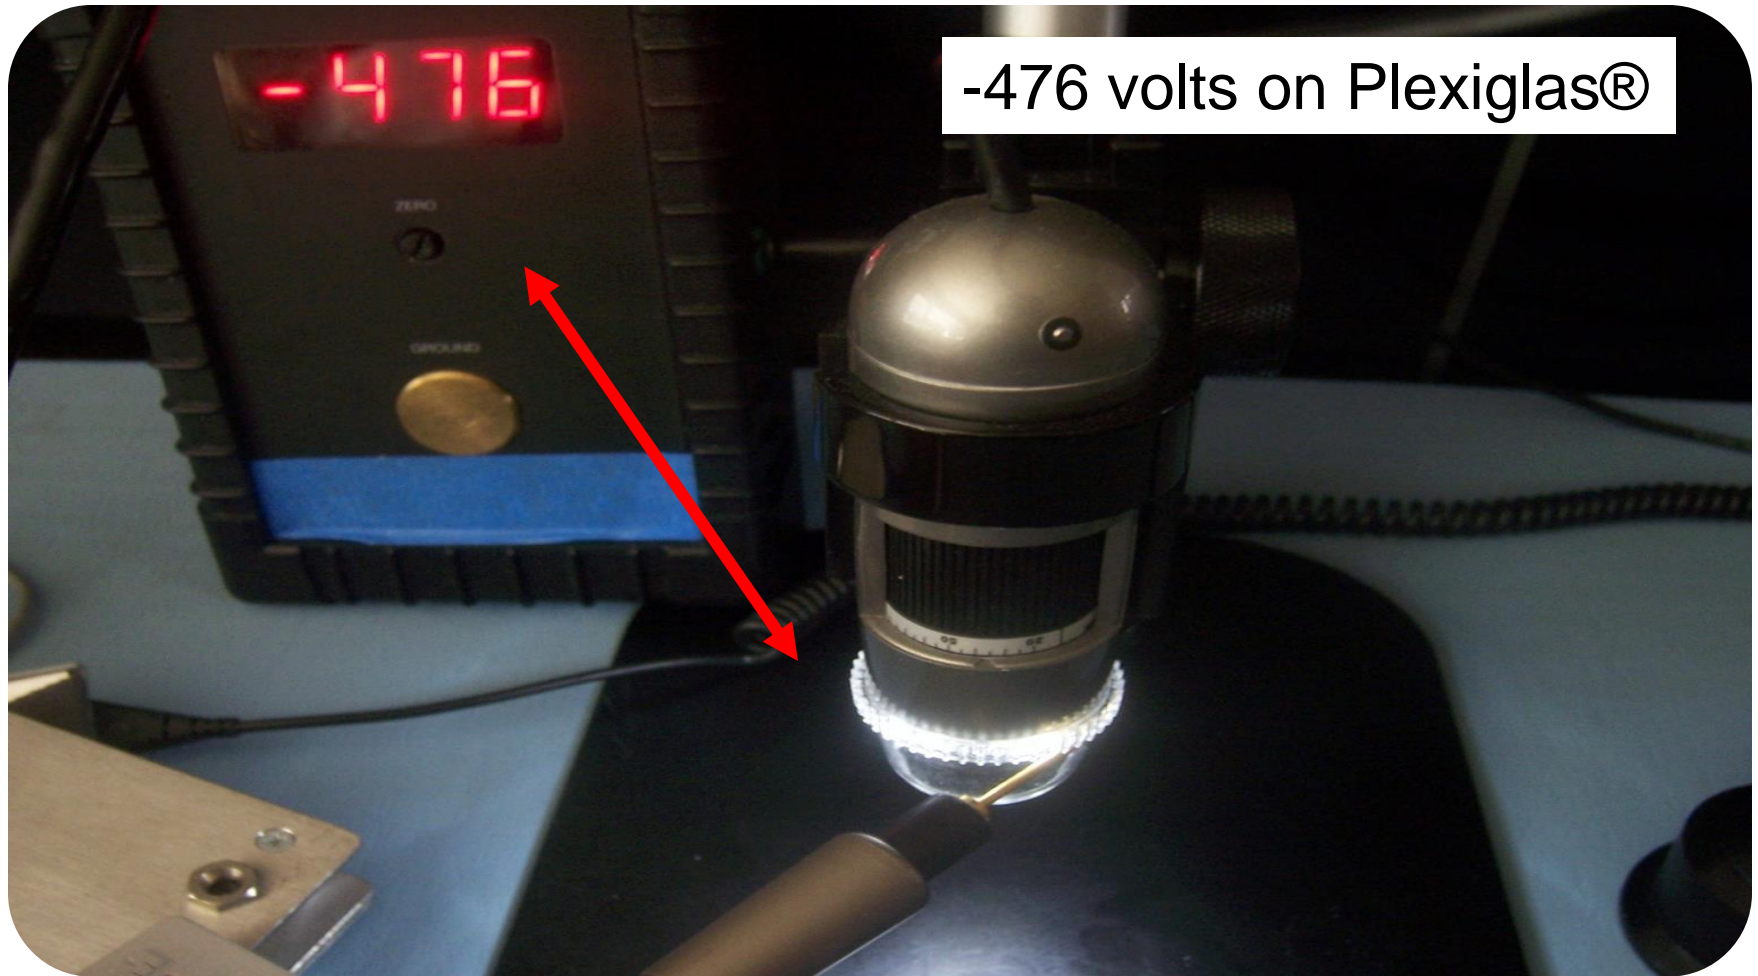
Contact Voltage Charge (Method 1)

Scope Charge at 1" From 3.5" x 3.5" 10pF Charge Plate (Proximity Voltage - Method 2)

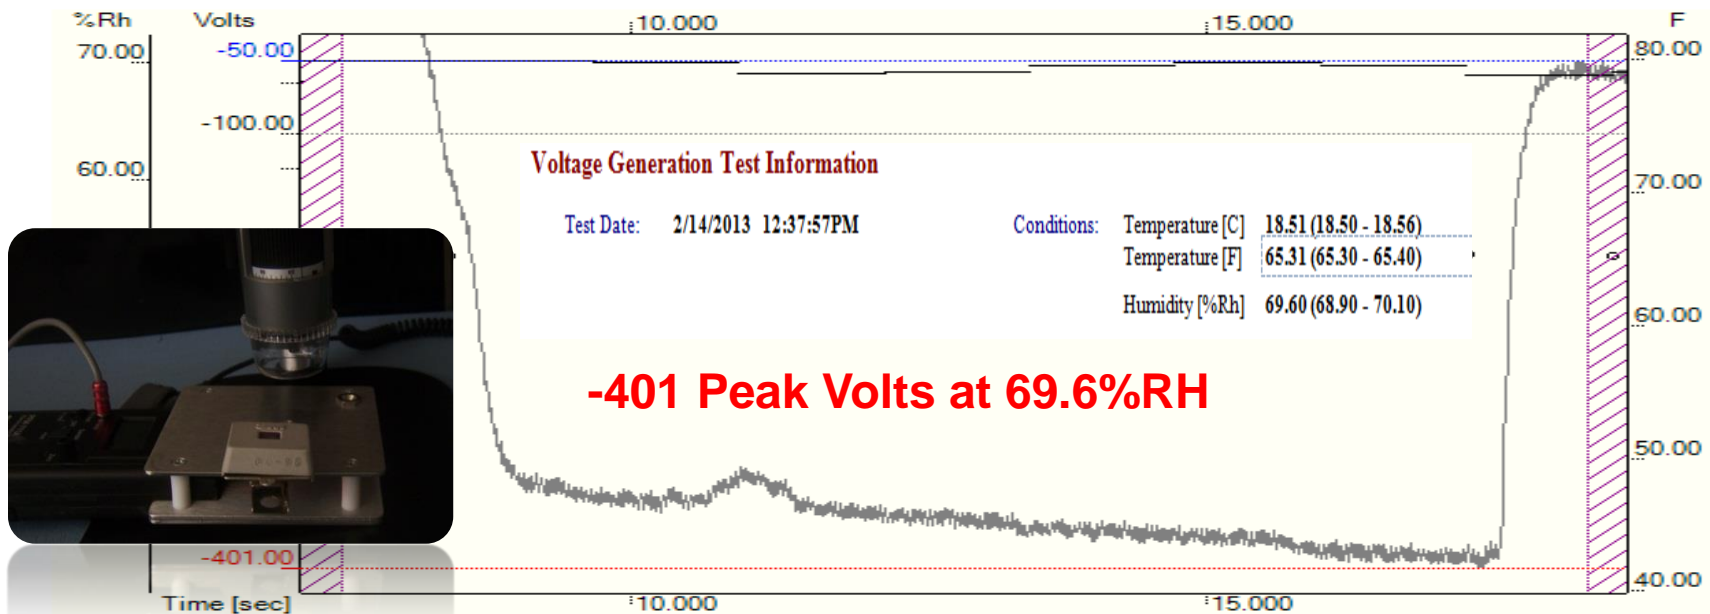
Voltage Generation Analysis Test Summary

Data Summary:

Number of Full Test Cycles:	1	Min [V] Data	Max [V] Data	Global	
Peak Recorded Values [V]:	-401.00	Average Voltage [V]:	-50.00	-401.00	-313.28
	-50.00	Standard Deviation:	-50.00	-401.00	-401.00
	0.00	Minimum Voltage [V]:	-50.00	-401.00	-401.00
		Maximum Voltage [V]:	-50.00	-401.00	11.00

100 volt ESD Event Detector Triggered

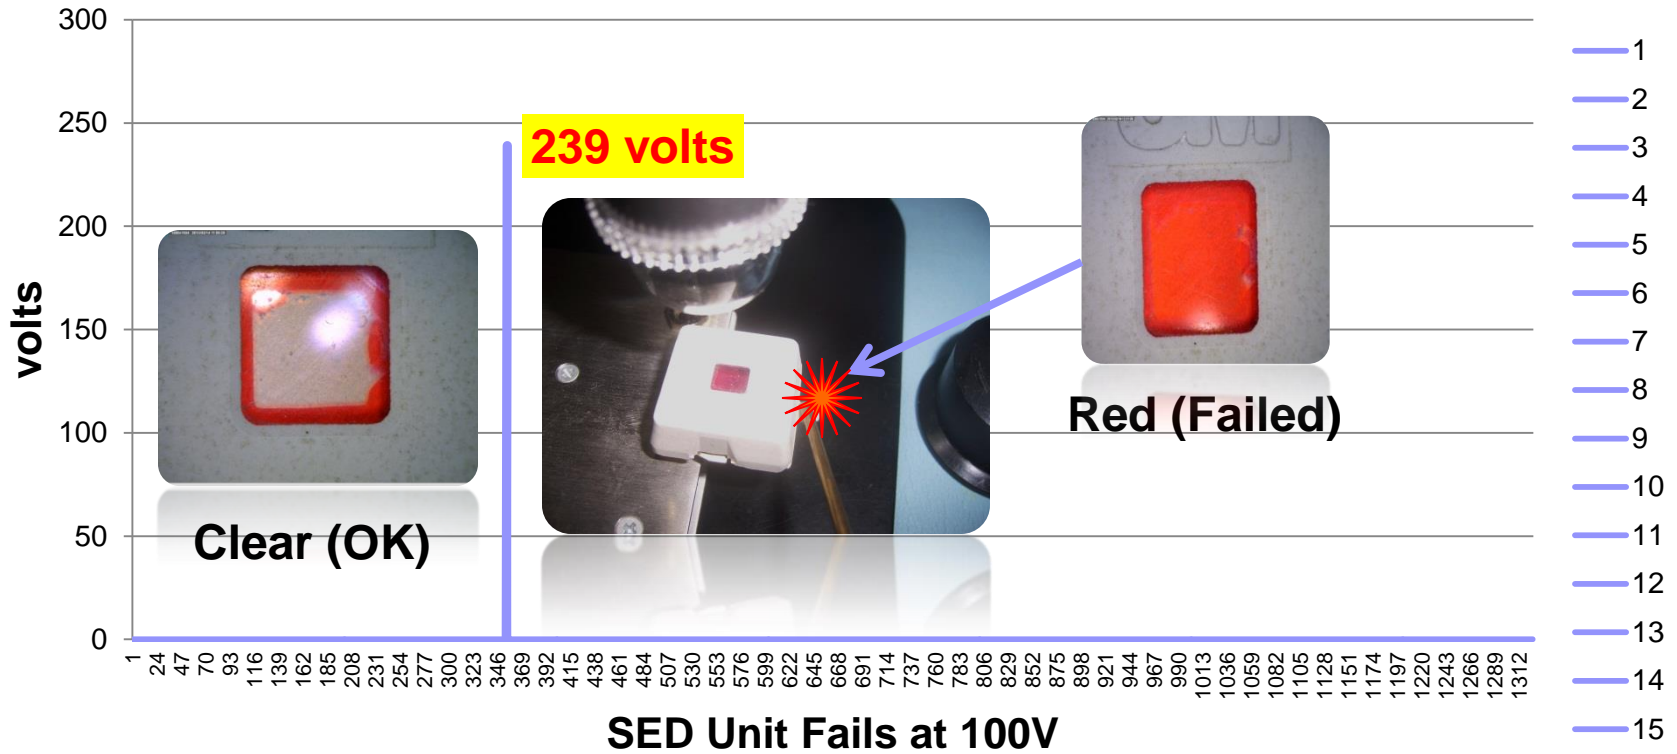
ESD Peak by Bringing Scope to SED Unit Using Grounded Brass Tip

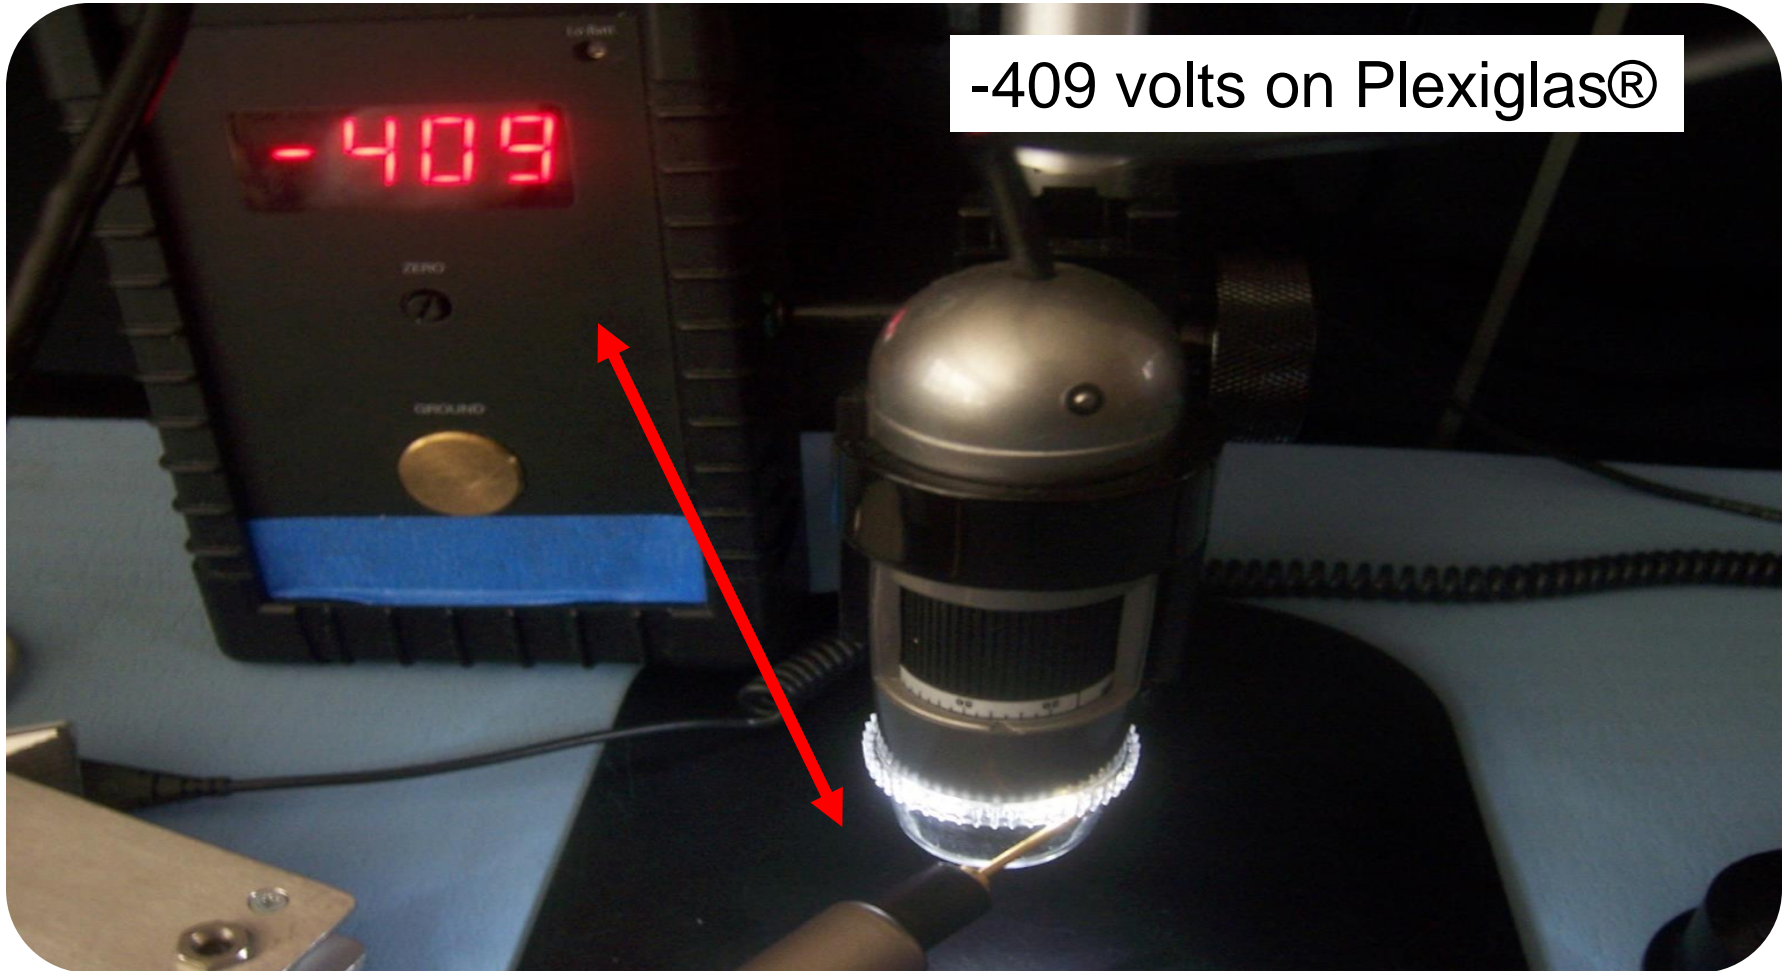
Contact Voltage Charge (Method 1)

Scope Charge at 1" From 3.5" x 3.5" 10pF Charge Plate (Proximity Voltage - Method 2)

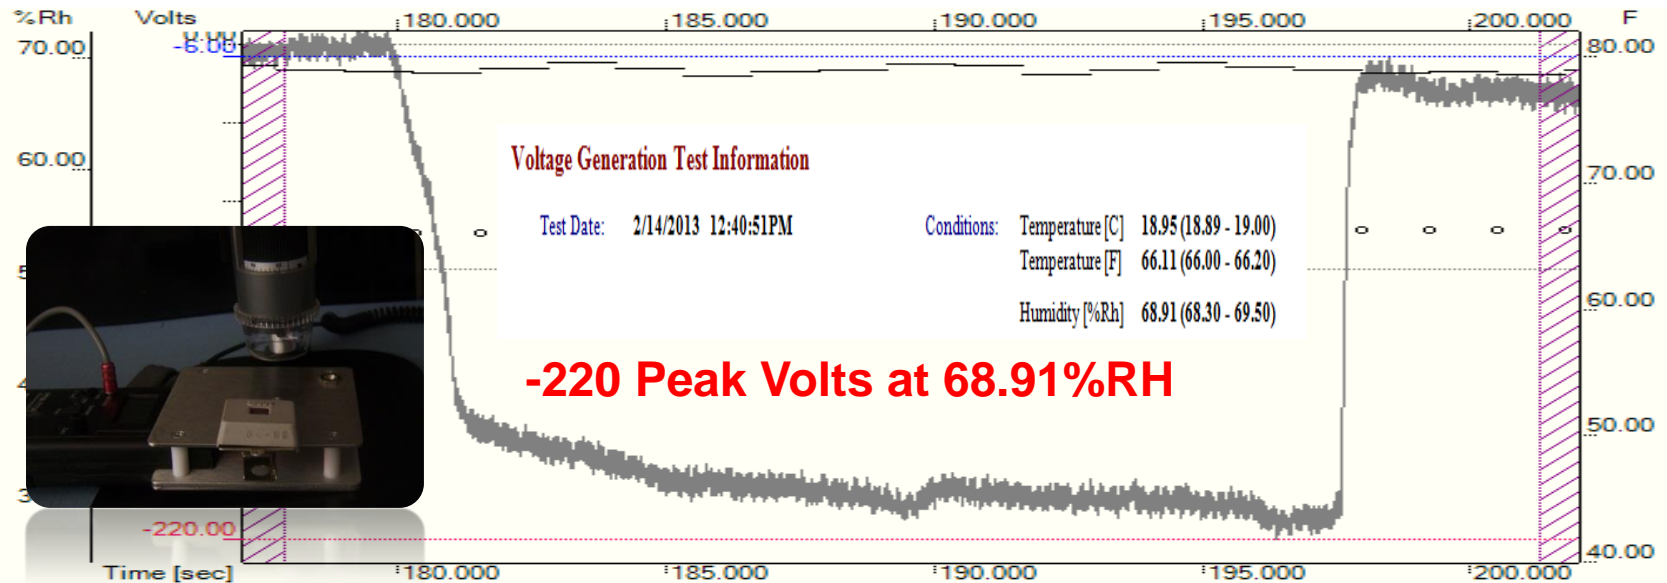
Voltage Generation Analysis Test Summary

Data Summary:

Number of Full Test Cycles:	1	Min [V] Data	Max [V] Data	Global
Peak Recorded Values [V]:	-220.00	Average Voltage [V]: -6.00	-220.00	-145.52
	-6.00	Standard Deviation:	-220.00	-220.00
	0.00	Minimum Voltage [V]:	-220.00	-220.00
		Maximum Voltage [V]:	-220.00	6.00

100 volt ESD Event Detector Triggered

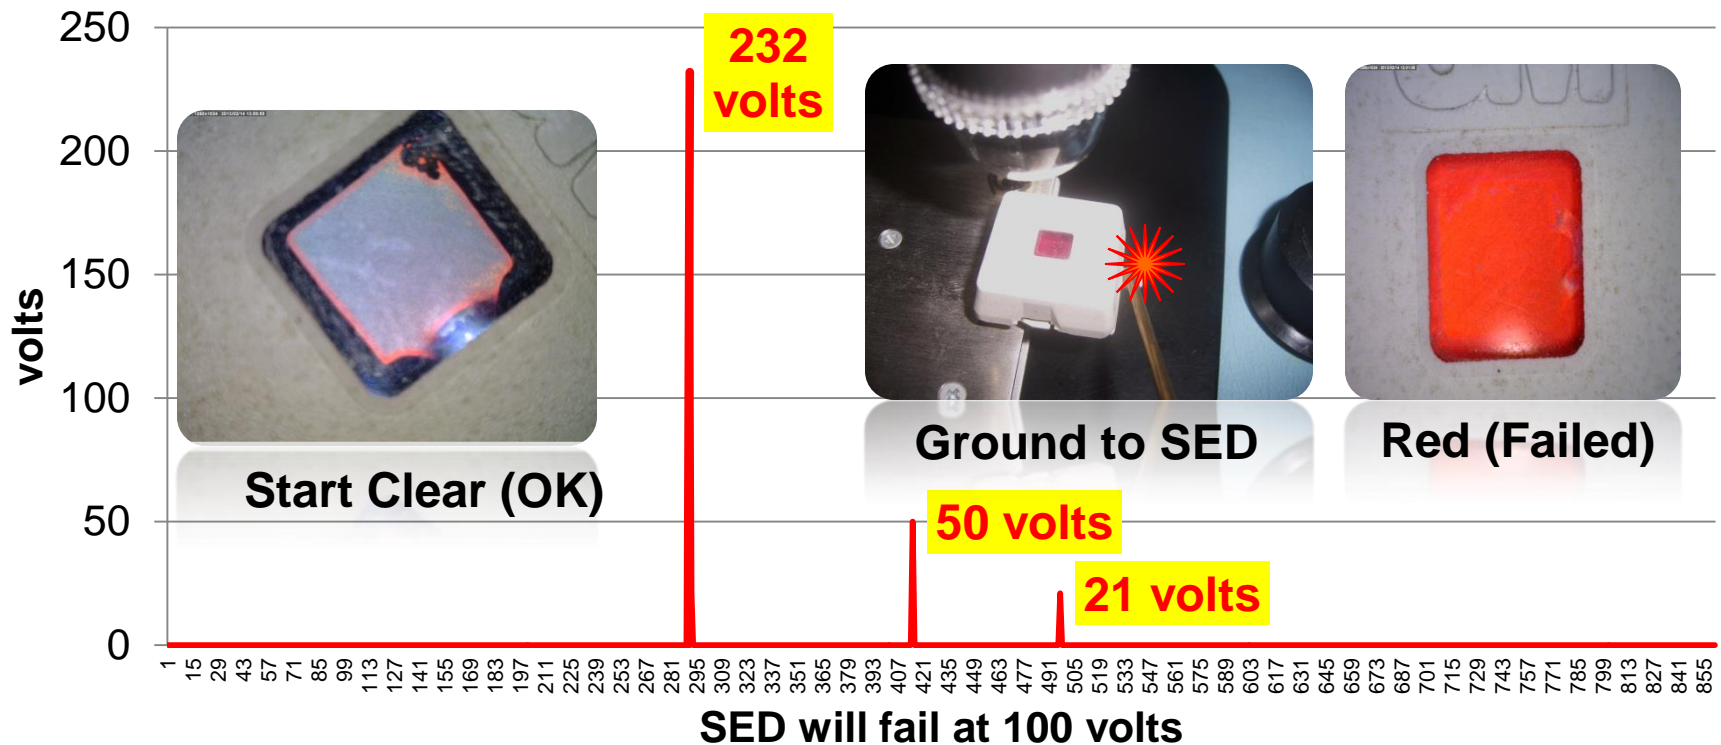
ESD Peak between Brass Tip and Static Event Detector (SED)

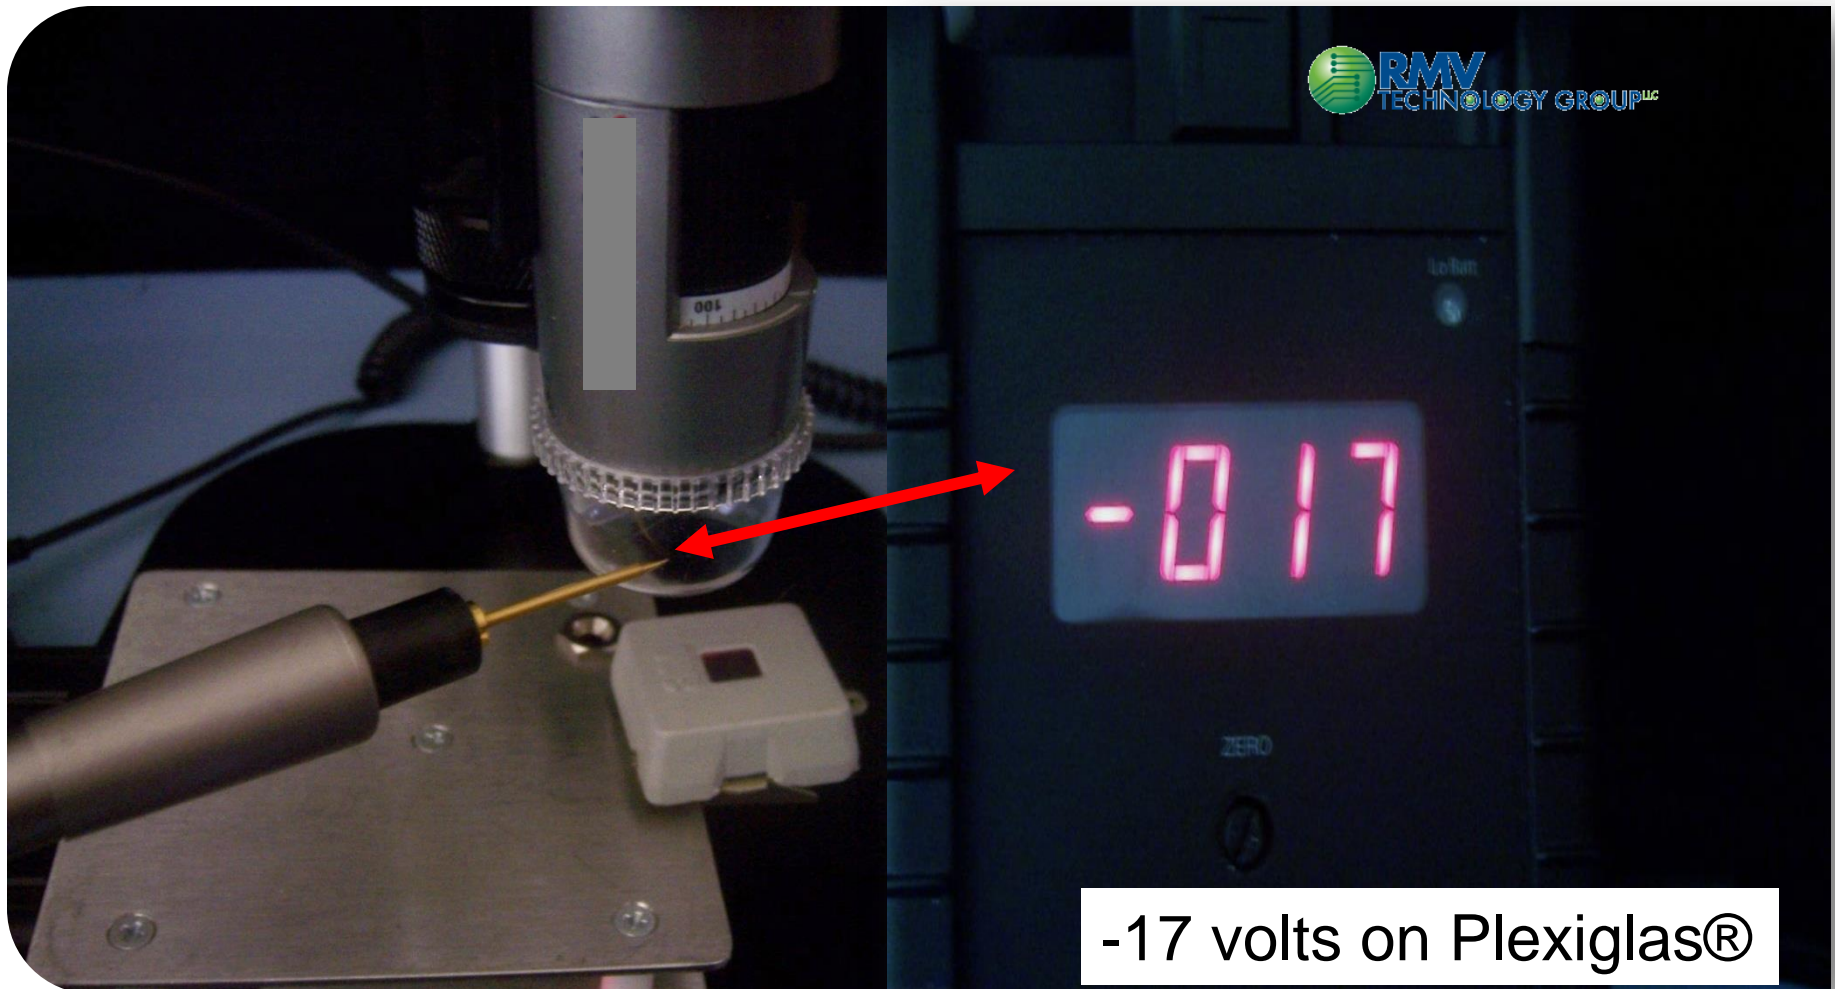
Scope under Ionization Flow

Scope Charge at 1" From 3.5" x 3.5" 10pF Charge Plate (Method 2, Under Ionization)

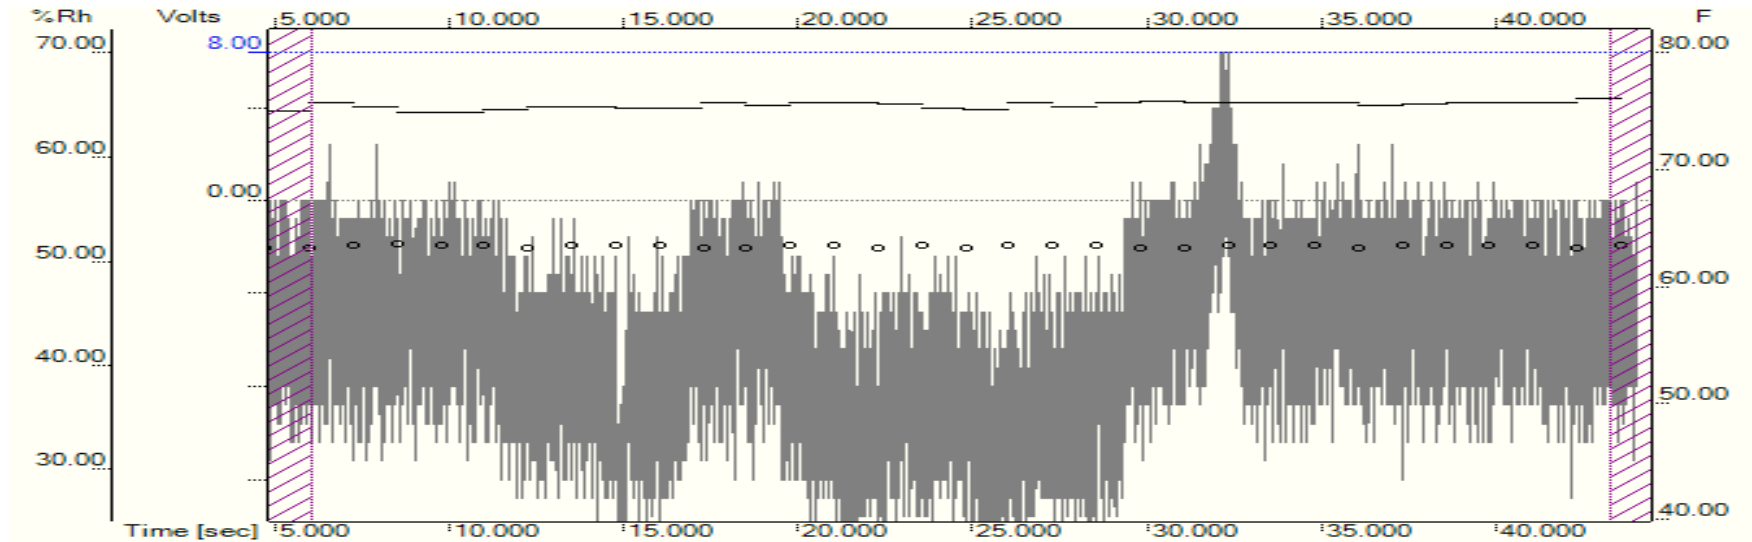
Voltage Generation Analysis Test Summary

Test Date: 2/14/2013 1:18:54PM

Conditions: Temperature [C] 17.47 (17.39 - 17.56)
Temperature [F] 63.45 (63.30 - 63.60)

-23 volts at 63.45%RH

Data Summary:

Number of Full Test Cycles:	1	Min [V] Data	Max [V] Data	Global
Peak Recorded Values [V]:	-16.00	Average Voltage [V]: 8.00	Standard Deviation: -16.00	-7.65
	8.00	Minimum Voltage [V]: 8.00	Maximum Voltage [V]: -16.00	-23.00
	0.00	Maximum Voltage [V]: 8.00		8.00

100 volt ESD Event Detector = Clear (Under Ionization)

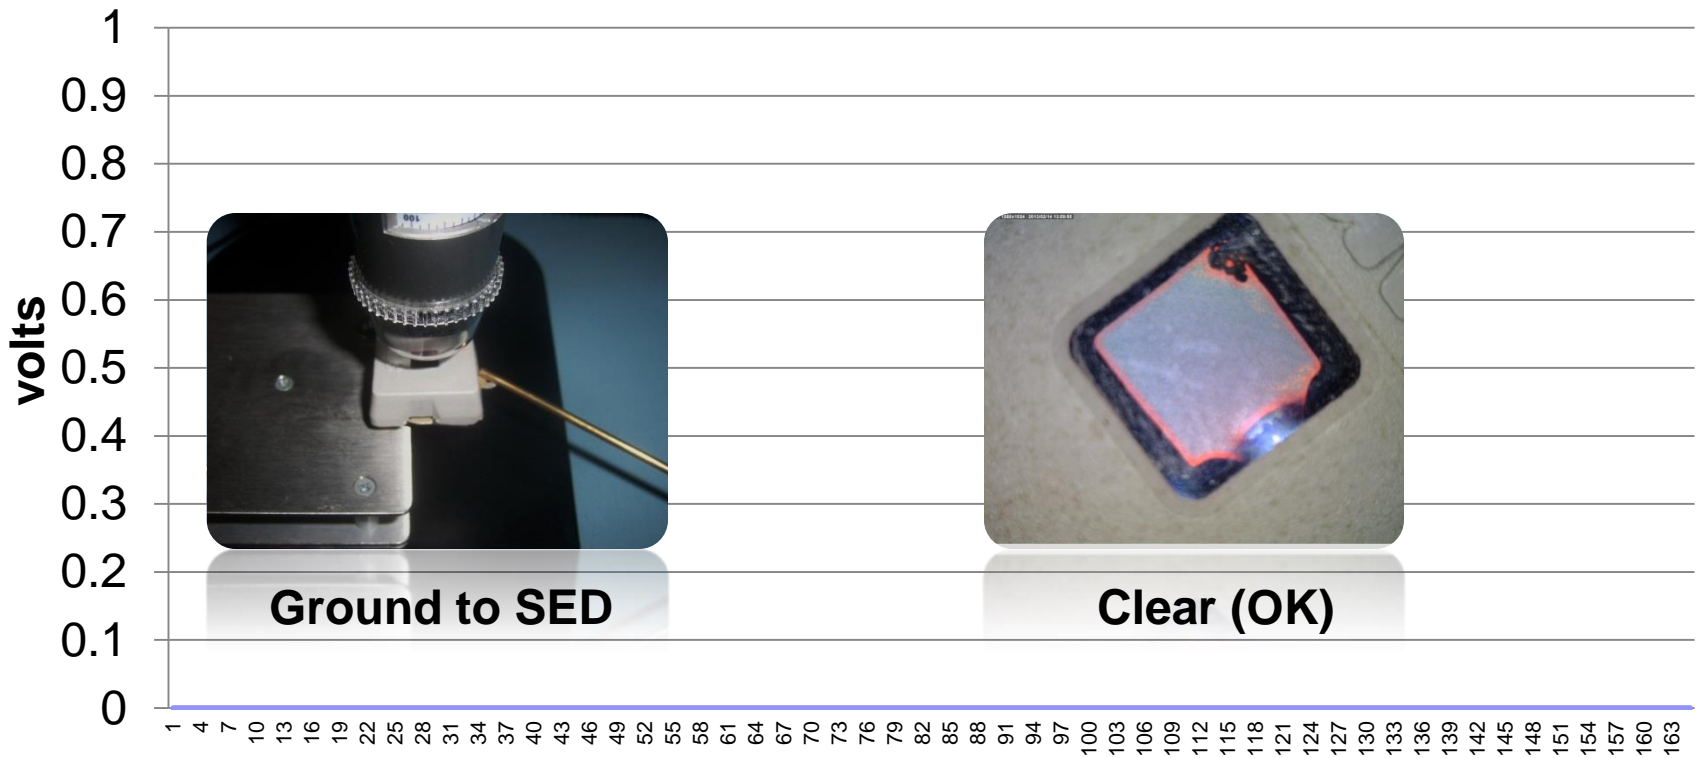
ESD Peak when Scope is Under Ionization Flow

SED Unit will Fail at 100 volts

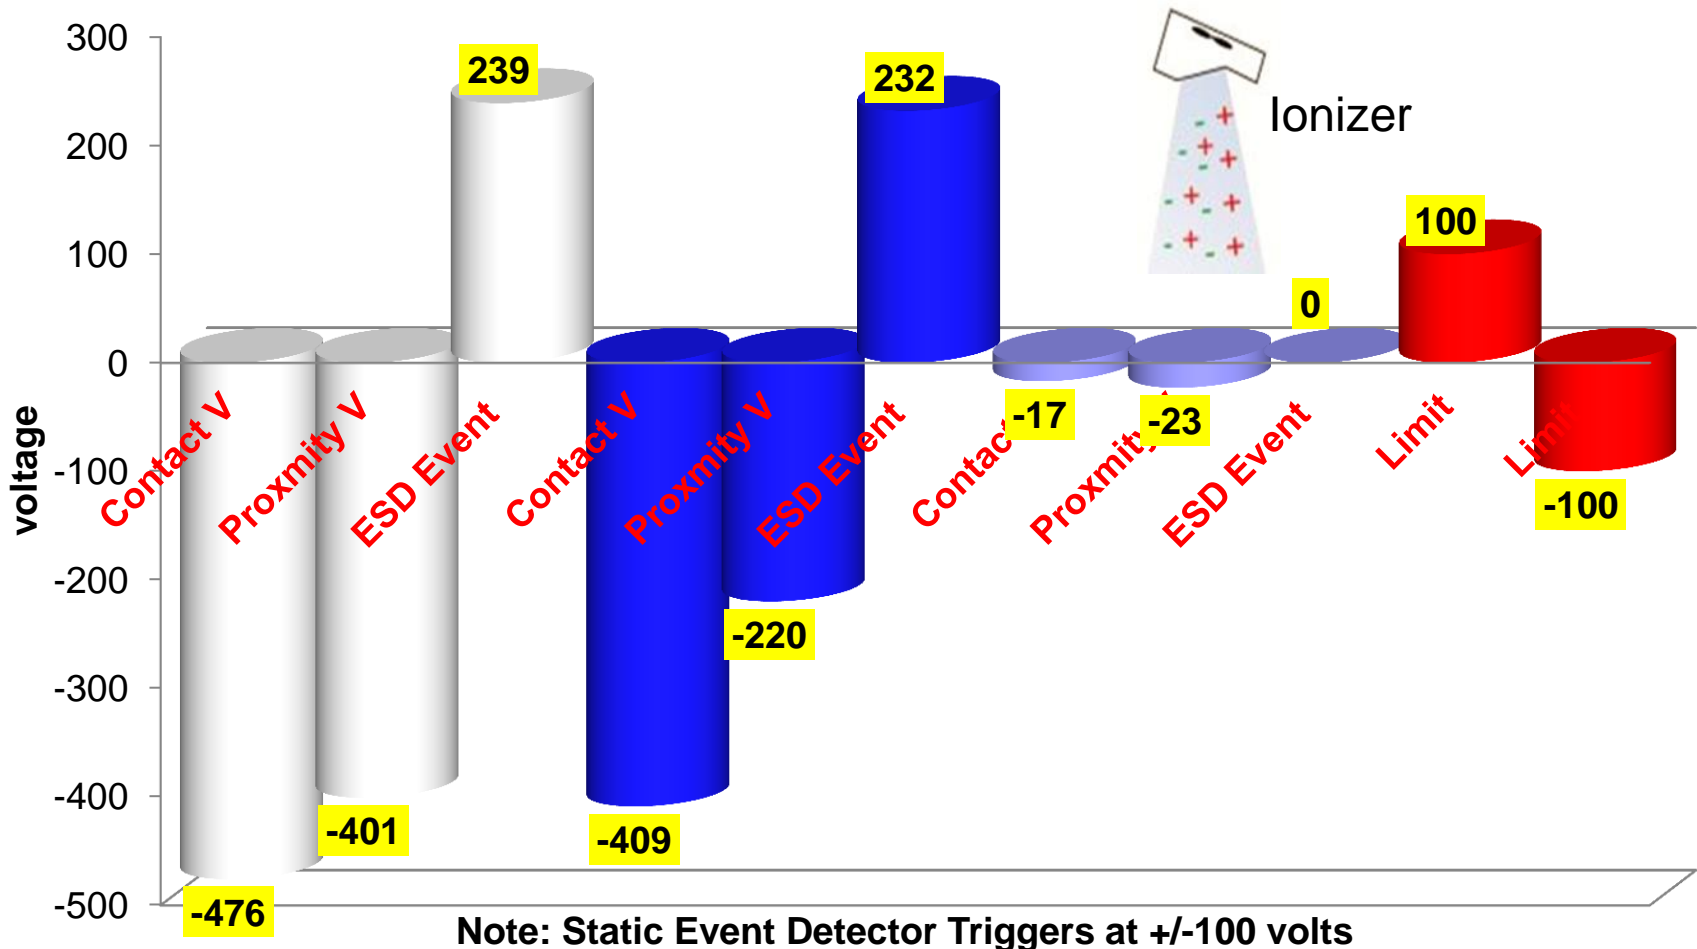
Summary of Findings

Contact Voltage/Proximity Voltage and ESD Events

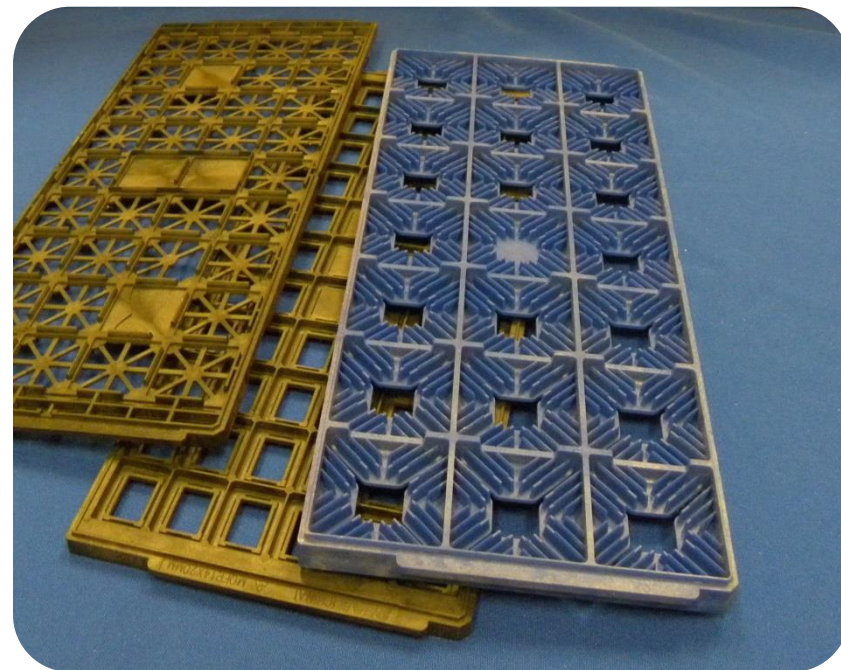
BOGUS Trays

1-Point Resistance through the JEDEC on Grounded Surface

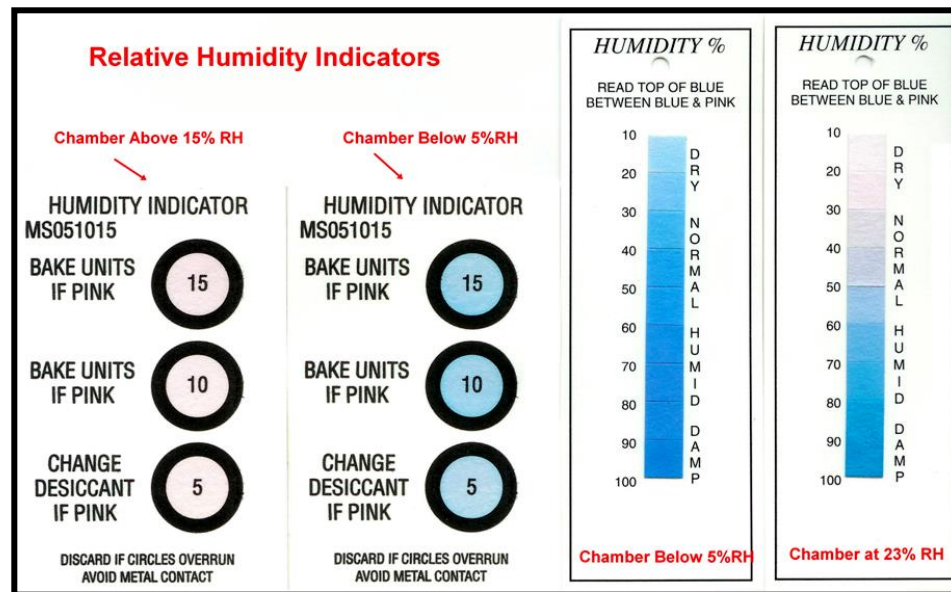
JEDEC Protocols

Once the JEDEC trays have been unitized, while grounded, place into a Type 1 Mil-PRF-81705E compliant aluminum Moisture Barrier Bag of the specified caliper along with a humidity indicating strip and then seal said package.

While grounded, place said JEDEC package into outer shipping package utilizing a rectangular BMC for placement into a Lock Front Mailer as illustrated in the next slide and close the outer packaging to apply the appropriate tamper resistant tape, RFID tag and printed labels.

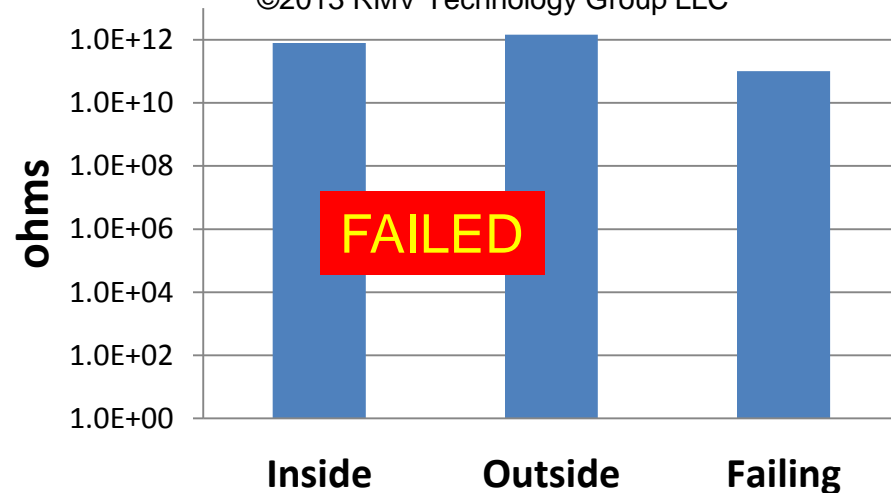
Surface Resistance Average Of Type 1 Bag

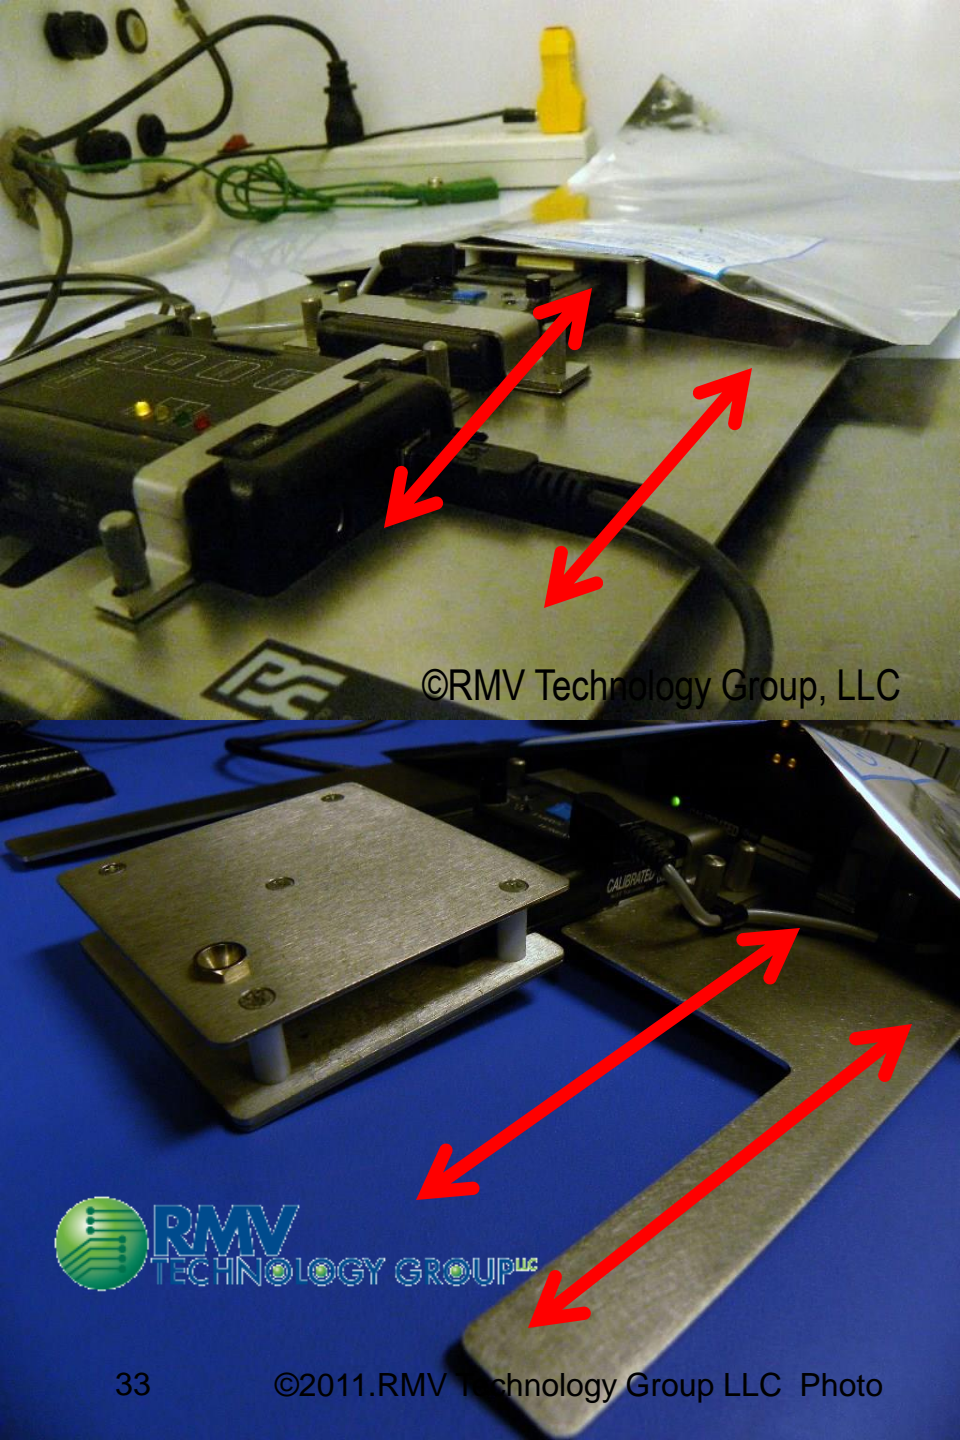
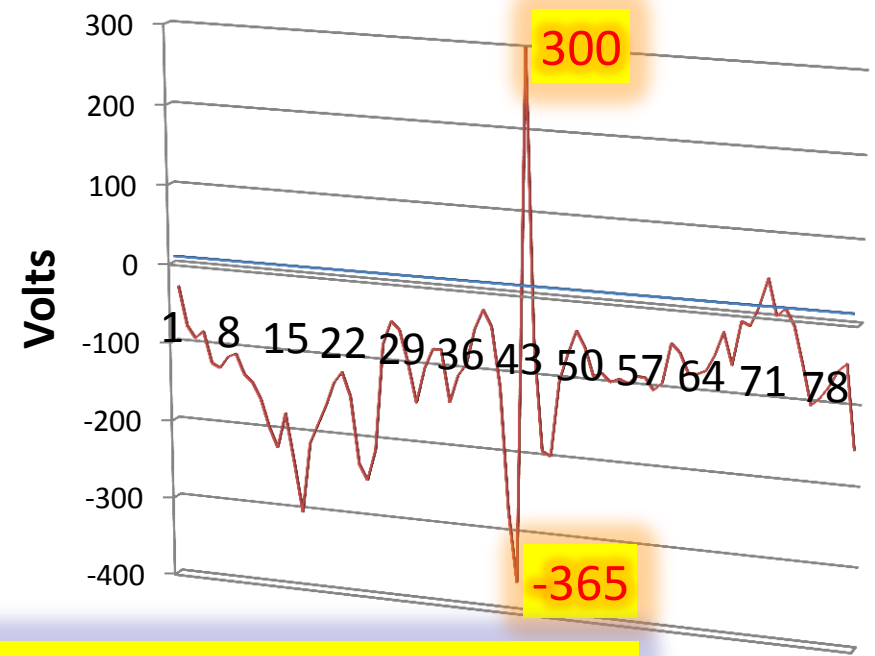
Charge Generation Pull from Bag

*A Bag Can See <4%RH
when Pulling a Vacuum*
