THE FAKE CISCO

Hunting for backdoors in
Counterfeit Cisco devices

Dmitry Janushkevich

Version 1.0, July 2020

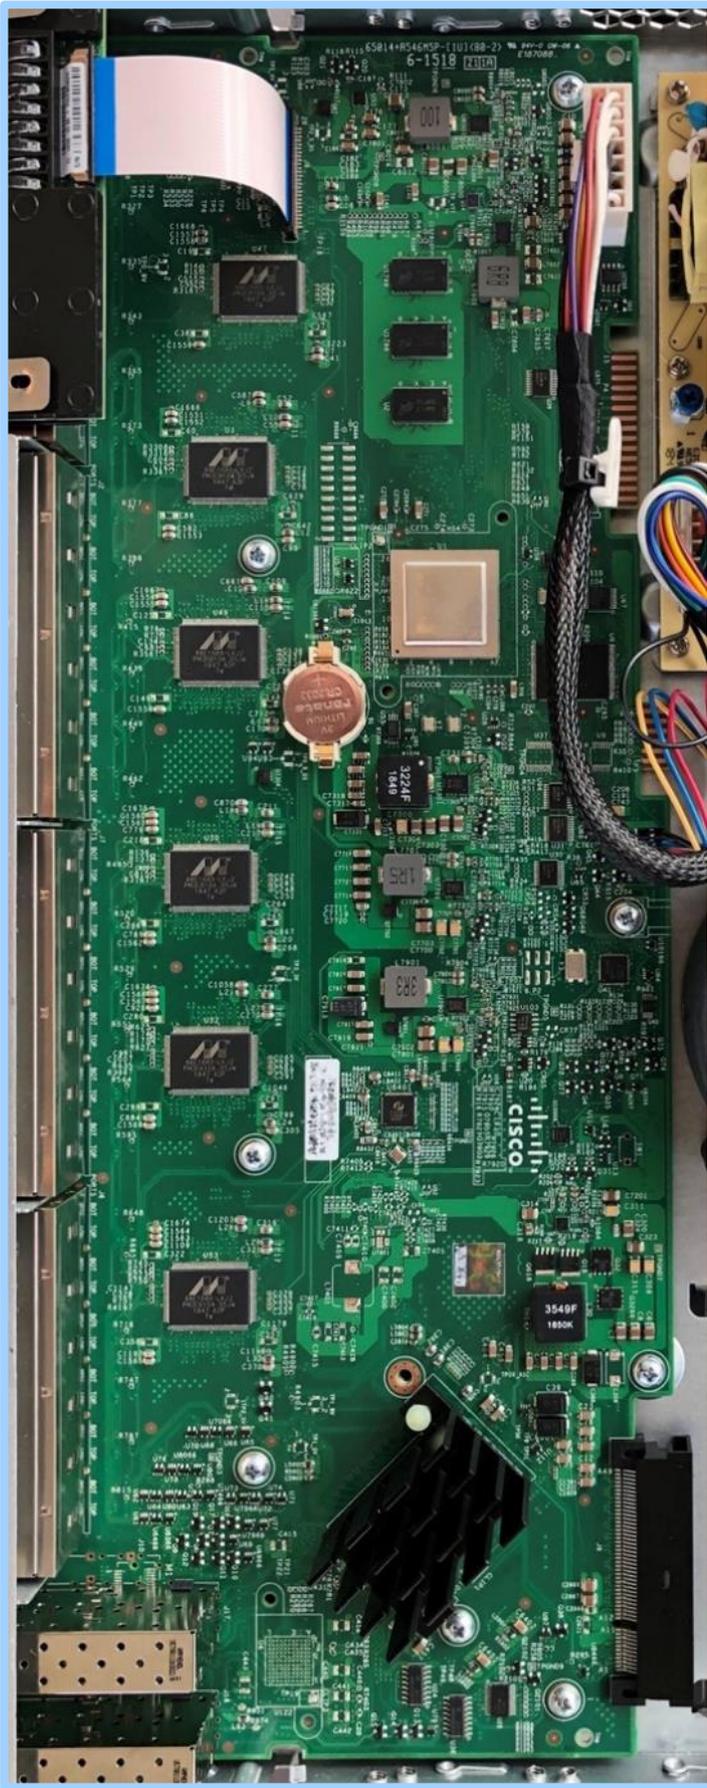
Figure 4. Genuine unit, internal view.

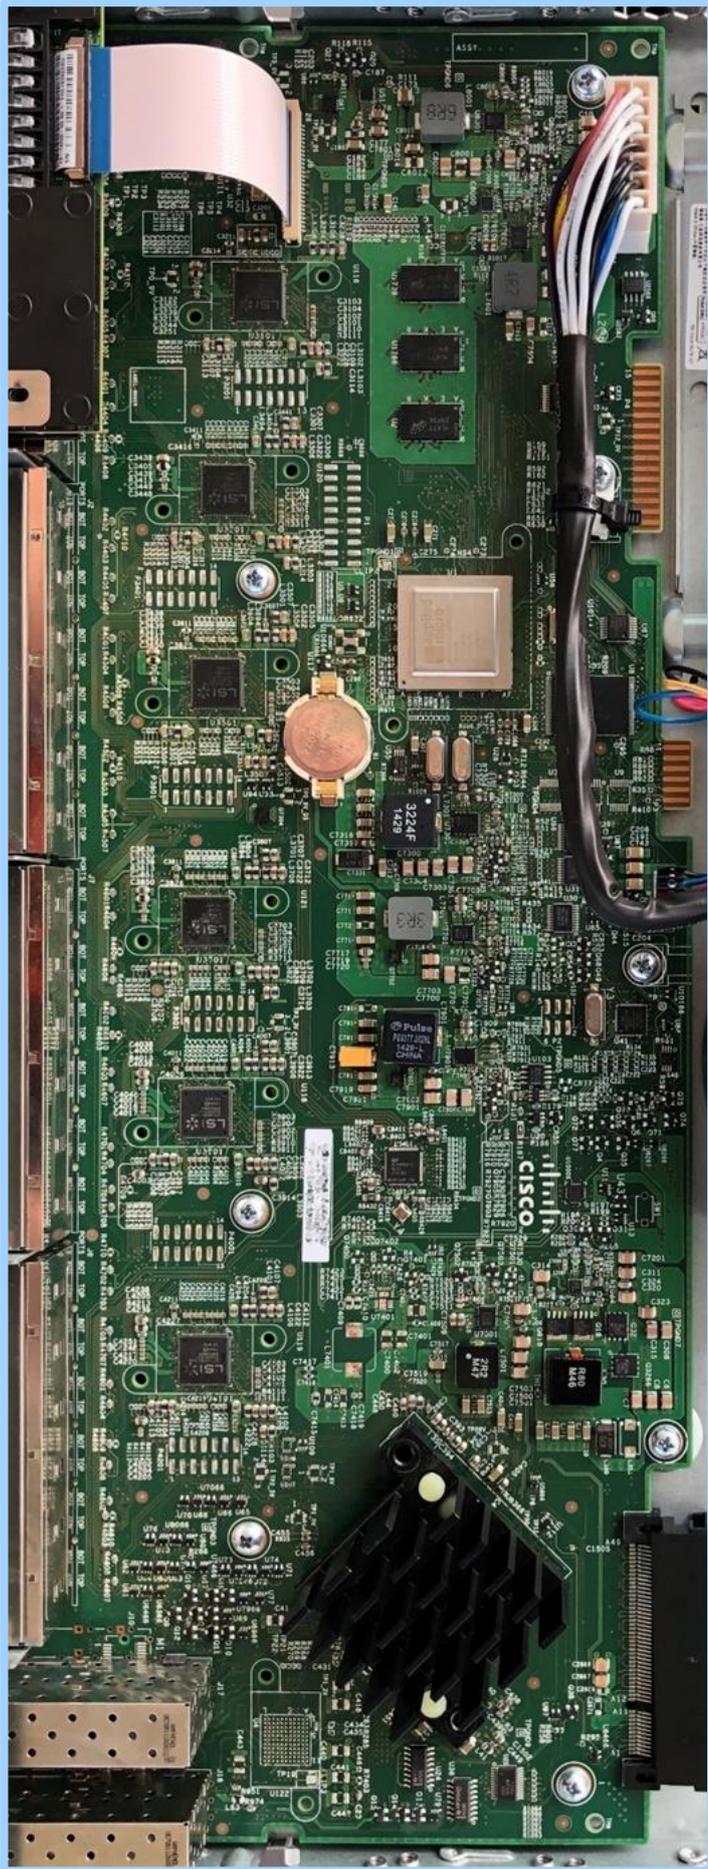
Figure 5. Counterfeit A, internal view.

What was more concerning, was the presence of PCB rework traces around the Flash IC on the Counterfeit A unit. While it could be the case the unit was legitimately repaired, no record of such activity was found via available sources. This led us to conclude that, at some point, the Flash chip had been replaced. This may have been part of legitimate repair activities; however, it is not typical for legitimate repair shops to leave flux residues on the board.

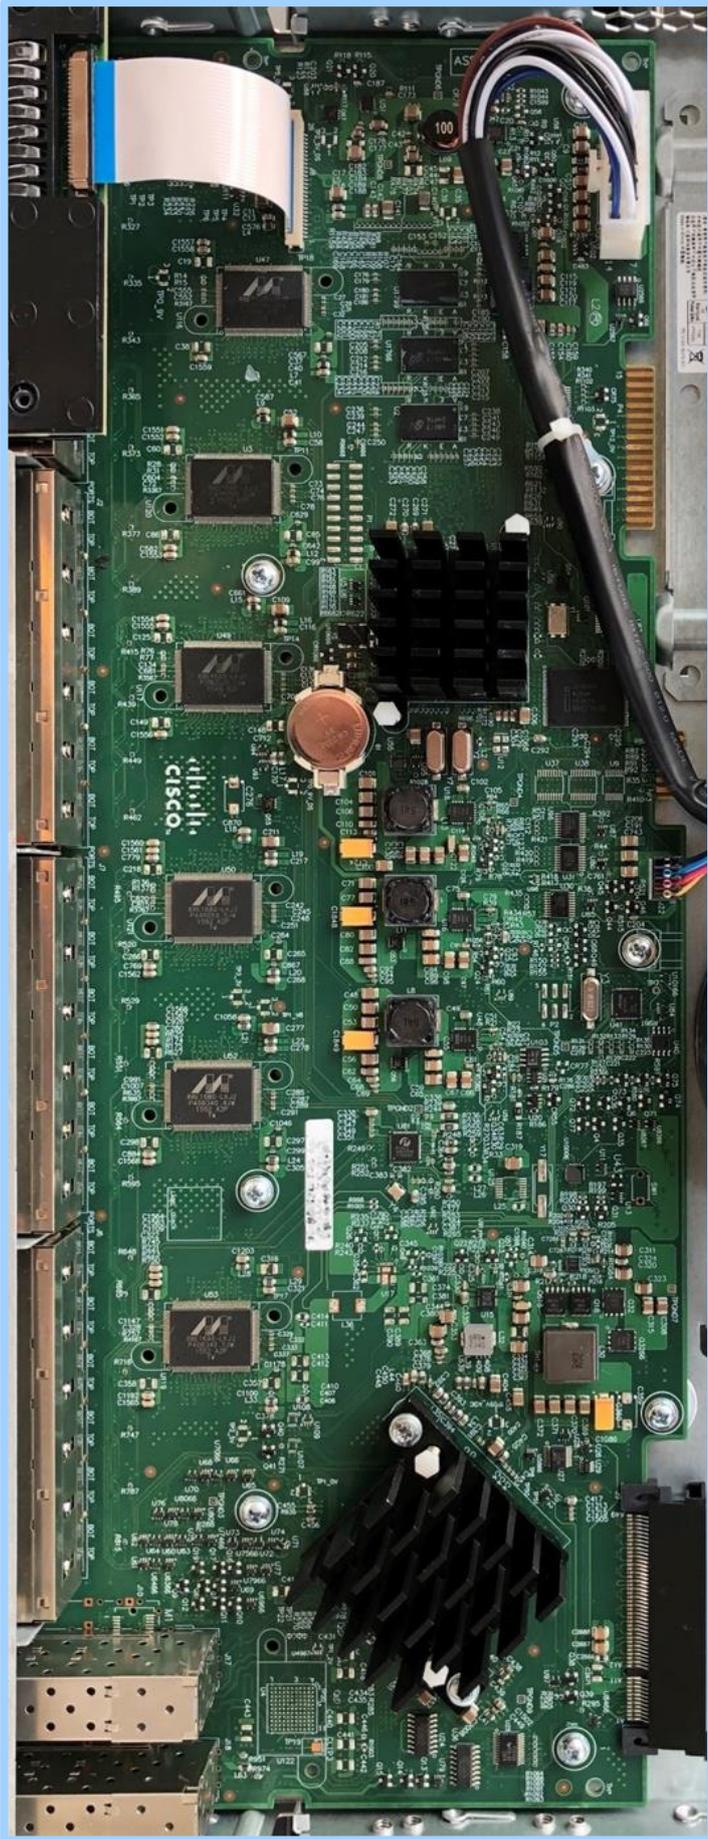
Figure 6. Counterfeit B, internal view.

The Counterfeit B unit was found to have one significant difference when compared to other units: the presence of components with their top marking removed with a laser; the components are U55 and U10006.

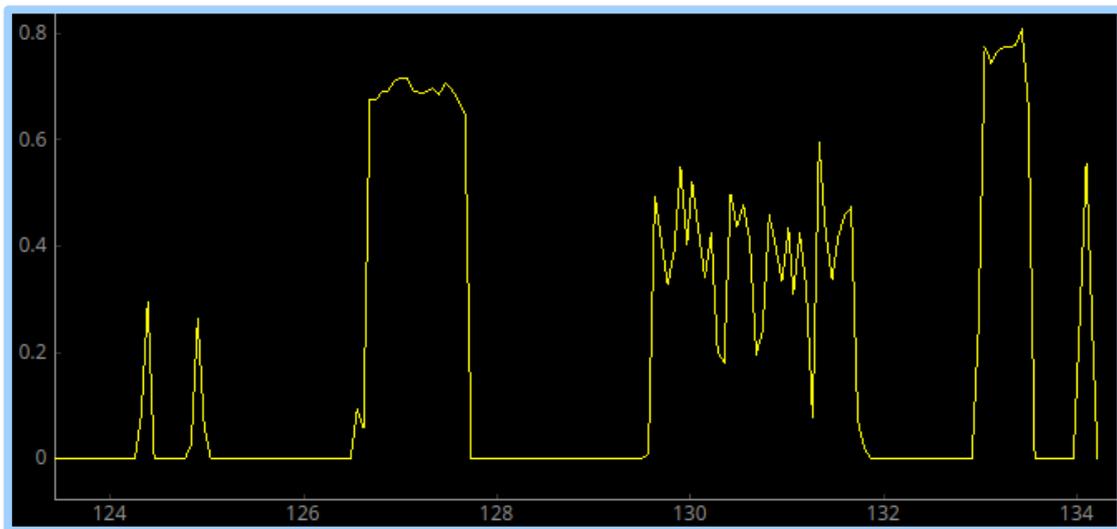
Figure 14. Zoomed view showing the very end of the image. The picture was very similar for all three Flash images.

Indeed, inspecting the last megabyte revealed the presence of what appeared to be two bootloader programs, easily identified with the help of embedded strings (examples from Counterfeit A):

These boot loaders corresponded to the last two peaks on the entropy graph above.

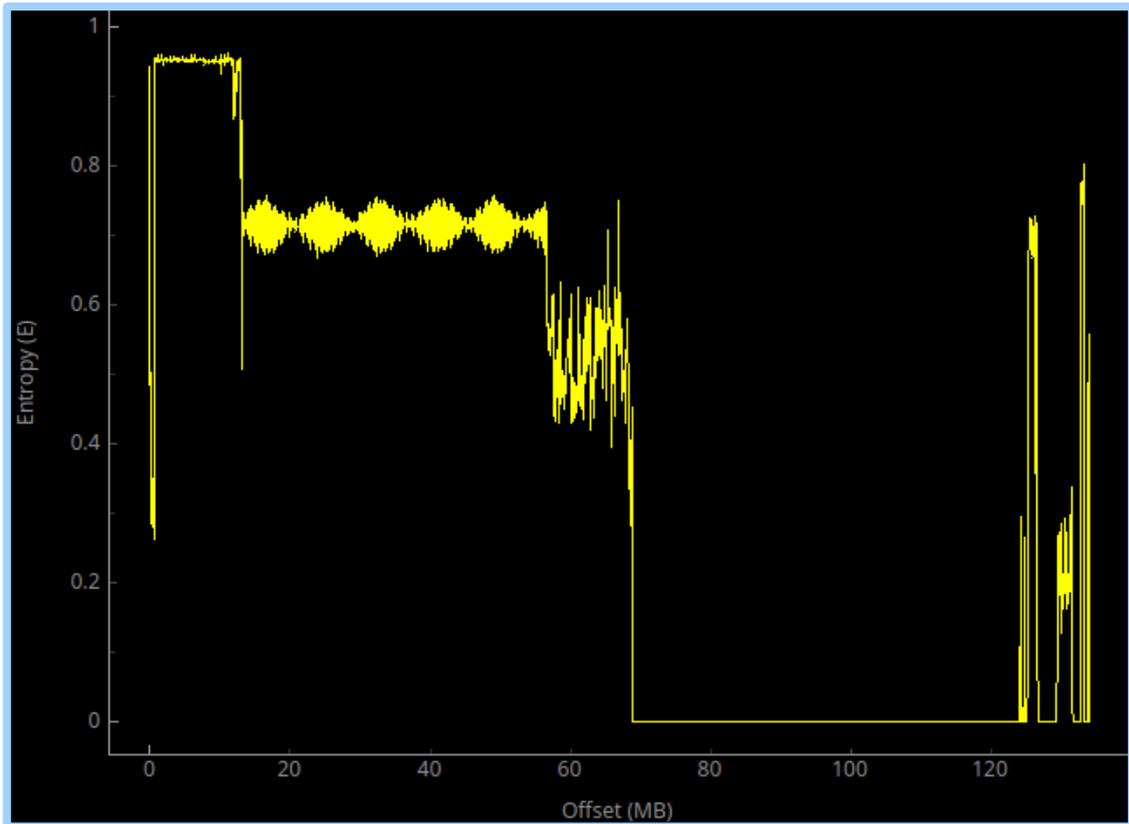
Figure 15. Entropy graph of the known-good Flash image obtained from the Genuine unit.

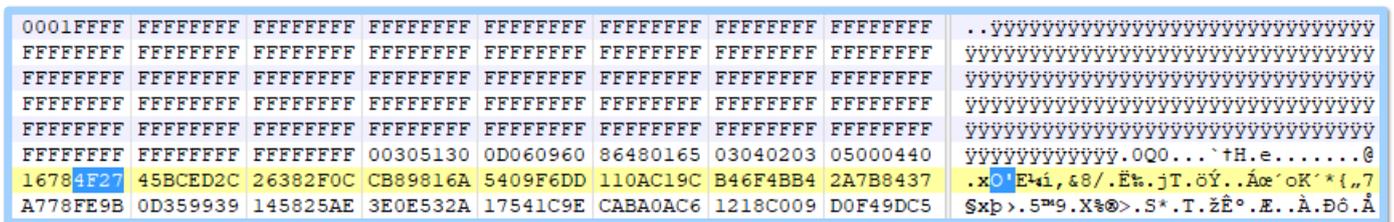
Figure 21. Decrypted BROM signature.

An immediate conclusion was that the second condition was used to circumvent the BROM signature check, while we could only assume that the first condition was somehow involved in circumventing HBOOT signature check.
