## A Rush To Judgment Is No Judgment at All

### A Prime Example of Rushing to Judgment

- A prime contractor ordered 25 pcs. PN: JM38510/05202BCA on 8/30/2011, for field use.
- The PO did not state any traceability requirement
- A test & inspection plan was agreed upon, and dictated on the PO. All the requirements of the PO were met and the parts accepted upon delivery 10/25/11.

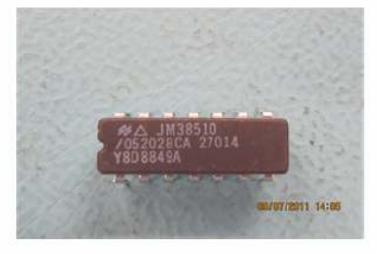
#### Visual Inspection

#### Typical Top Surface

Comments: No anomalies detected to indicate parts are remarked or refurbished

Evidence of Sanding? NO Evidence of Blacktop? NO Pin 1 Indicator Blacktopped? NO Evidence of Re-marking? NO

Major corrosion on leads? NO Solder on leads? NO Evidence of Refurbishment? NO Leads are Re-Tinned? NO

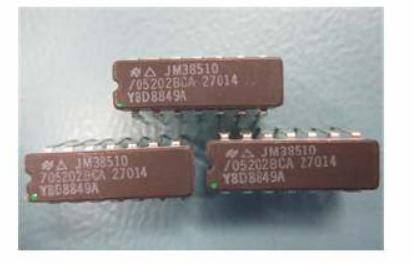
Pre-Scrape 3 Samples

Scrape Test For Blacktop

Applicable to Device Type? YES Blacktop Detected? NO

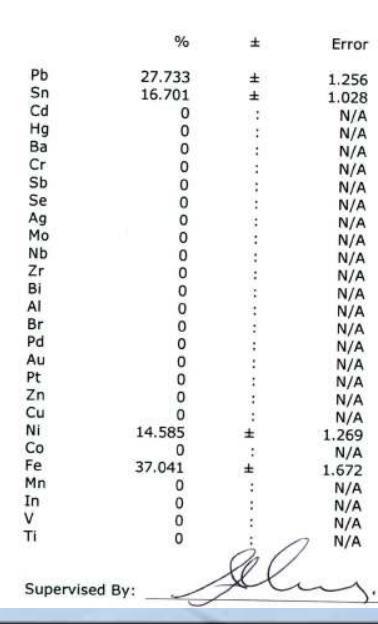
#### XRF ANALYSIS

Electronics Metals 2012-05-08 15:03 20.00 % Final No Match : \*5.87 3mm

atin: SnPb.

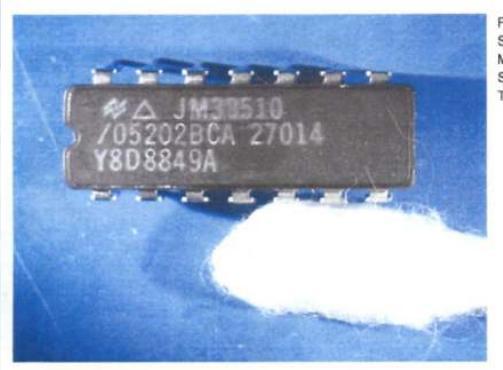
FIGURE: 2 SAMPLE: 1 MAG.: N/A SUBJECT: TOP VIEW OF DEVICE.

VIEW: POST- DYNASOLVE ANALYSIS IN ACCORDANCE WITH NJMET PROCESS NO:PP7750

NO ANOMALIES OBSERVED

LOT DISPOSITION: PASS

Examination of the top surface of the ceramic packages of this lot of parts shows it to be the native surface without any coatings.

Uncoated ceramic surfaces, such as the brown ceramic lid on these devices, are slightly abrasive. Examination of these parts showed metallic streaks to be present from normal process handling which has occurred during manufacture, before these parts were received by CTG. These streaks are caused when the metal leads, being much softer that the ceramic, are abraded by the ceramic, leaving a trail of fine metal particles embedded in the ceramic surface, thus the marks... To verify this, the leads of a second device were used to gently mark an "X" on the right-side of one part from the lot concerned, as shown in the attached photograph. Should the top of the part have been coated, it would not have been possible to create the "X" by abrasion.

Thus, no evidence of external damage, defects or reworking was found with these parts.

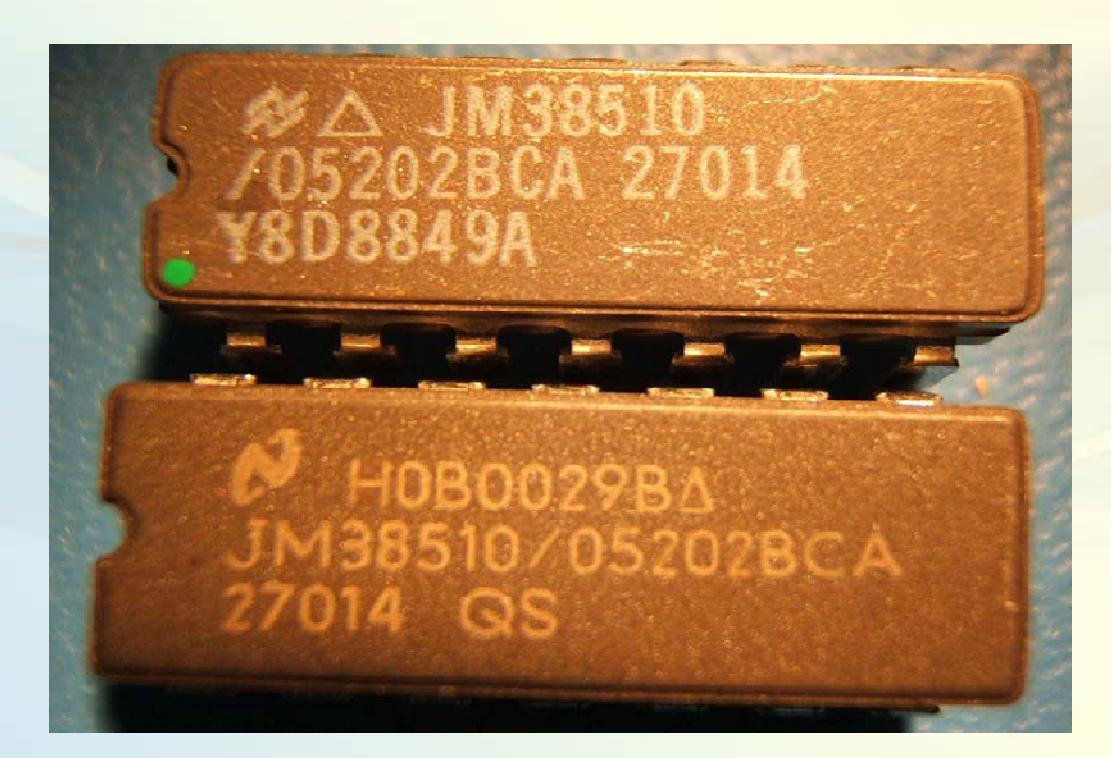
#### **Photo Comparison**

#### **TI <u>Still</u> Insists Part Looks Blacktopped**

#### This example appears to have had ink mark rework. Looks like this is is a black top ink over the ceramic surface.
