# DOD SUPPLY CHAIN

## Suspect Counterfeit Electronic Parts Can Be Found on Internet Purchasing Platforms

## DOD SUPPLY CHAIN

### Suspect Counterfeit Electronic Parts Can Be Found on Internet Purchasing Platforms

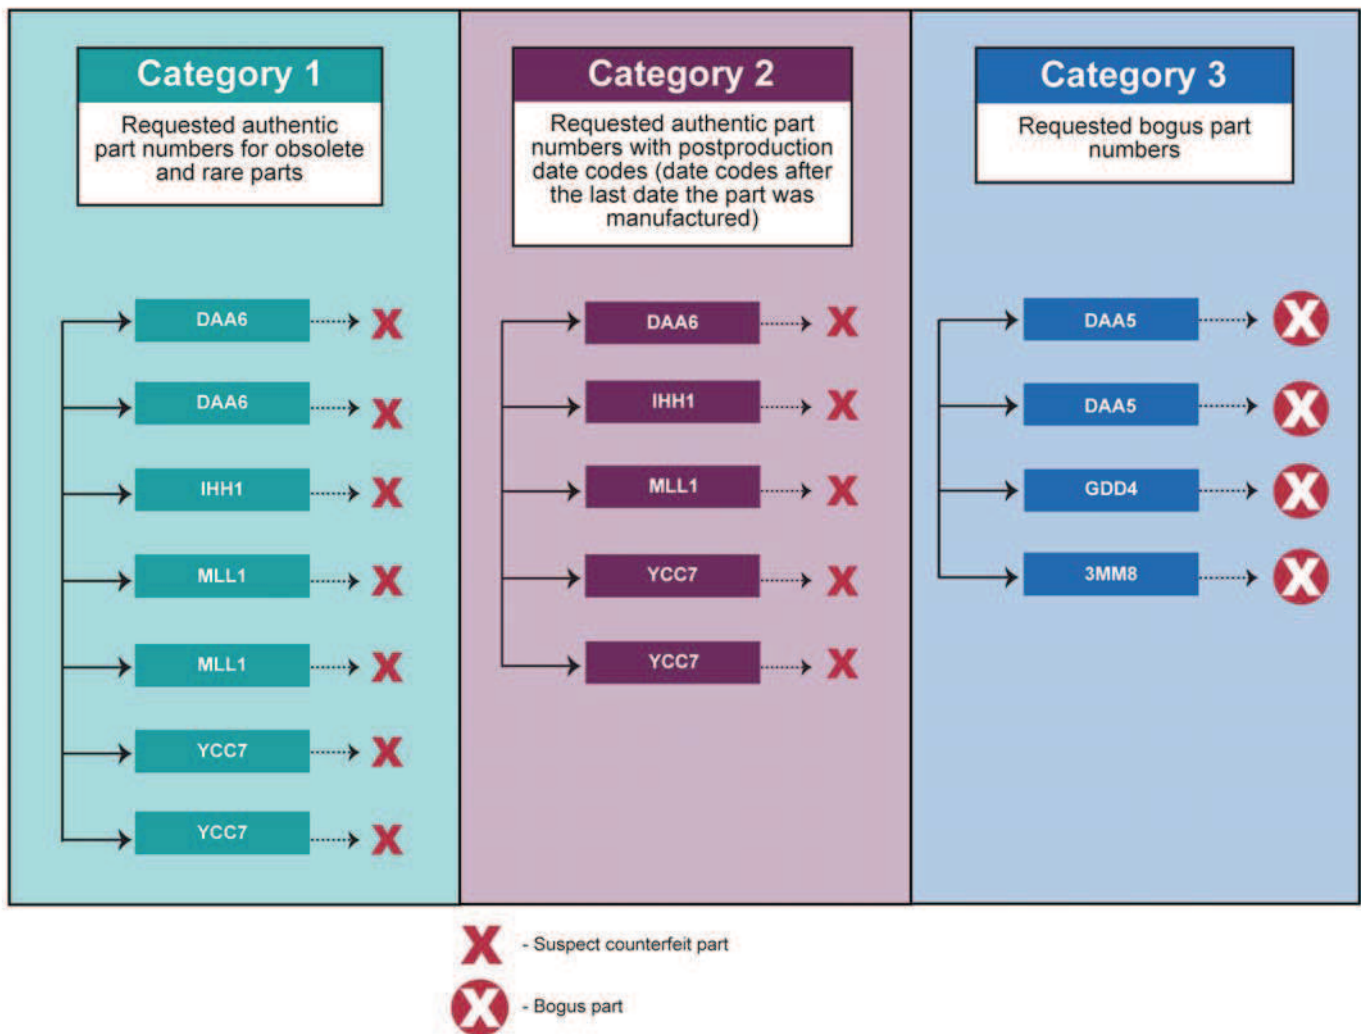
Figure 1: Status of Parts Purchased and Tested

As shown in figure 1, each of the 16 parts we purchased was either suspect counterfeit or bogus. Specifically, all 12 of the parts we received after requesting authentic part numbers (either with valid or invalid date codes) were suspect counterfeit, according to SMT Corp. In addition, vendors provided us with 4 bogus parts after we requested invalid part numbers, which demonstrates their willingness to sell parts that do not technically exist. The following sections detail our findings for each of the three categories of parts we purchased.

Source: GAO analysis of SMT test results.

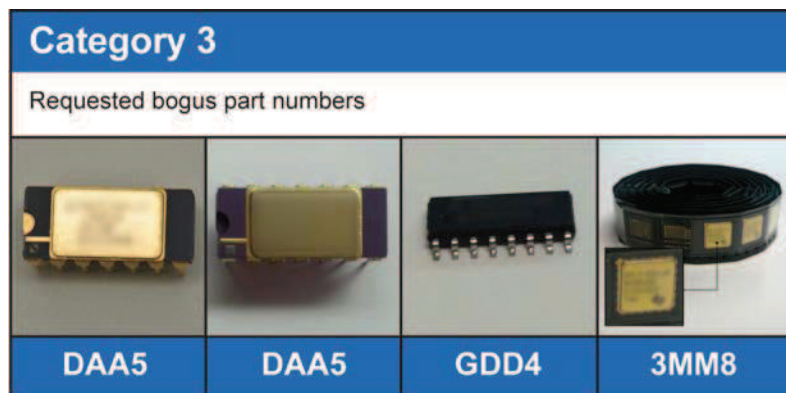
**Figure 4: Photos of Parts Received Despite Request for Invalid Part Numbers**

We received the four bogus parts after requesting invalid part numbers DAA5, GDD4, and 3MM8. We made two orders using DAA5, one from each Internet purchasing platform, which were fulfilled by different vendors. The parts we received from each vendor appeared similar, as shown in figure 4. The similarity may be due to a number of factors. For example, the vendors could have simply ignored the invalid portion of the

part numbers we requested (they did not contact us to inform us that the numbers were invalid). Another possible explanation could be that the parts happened to be fulfilled by the same vendor operating under two different names.
